Geberit toilet flushing Replacement of the seal

If water runs through a Geberit toilet flush, it may be necessary to replace a gasket.

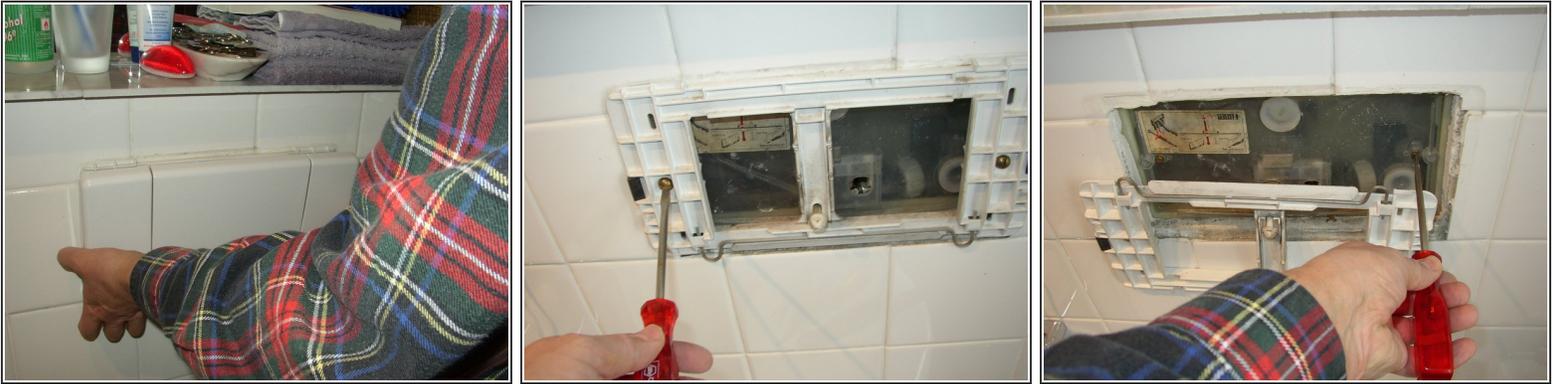
Step 1 — Remove cover (flush-mounted model)

- Lift pressure plate from bottom to top, then remove
- first unscrew the outer frame
- then the inner cover. Carefully pull away to the front.

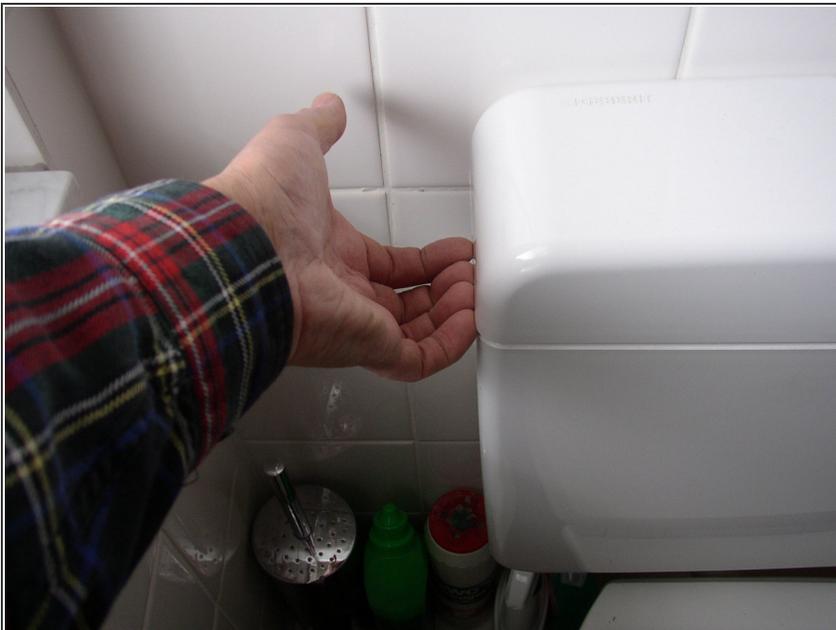
Step 2 — Surface model

- Grab left and right and pull up quite vigorously.

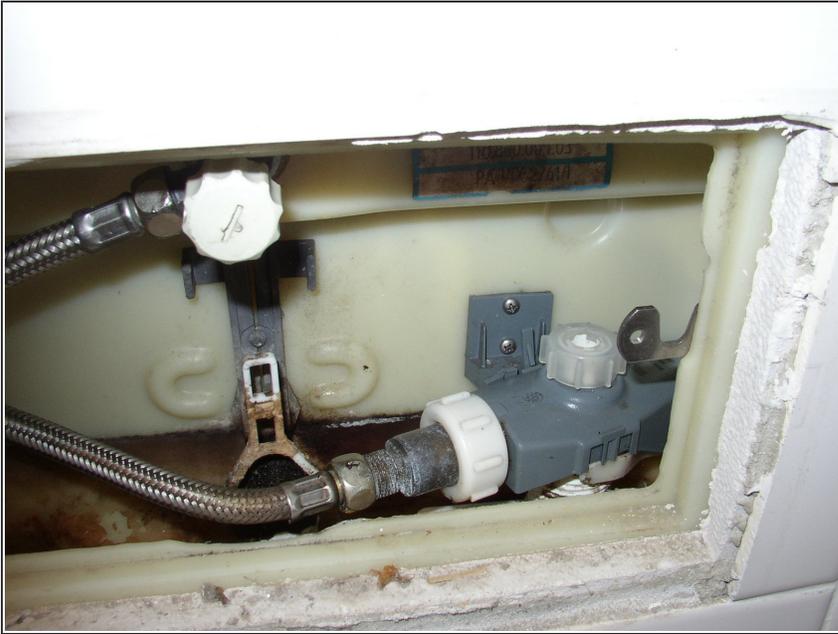
Step 3

Be sure to turn off the water inlet, e.g. at this corner tap.

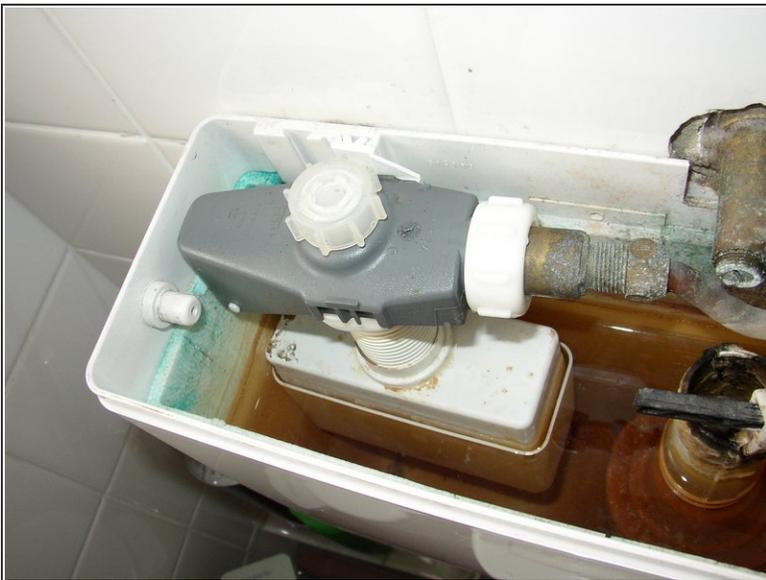
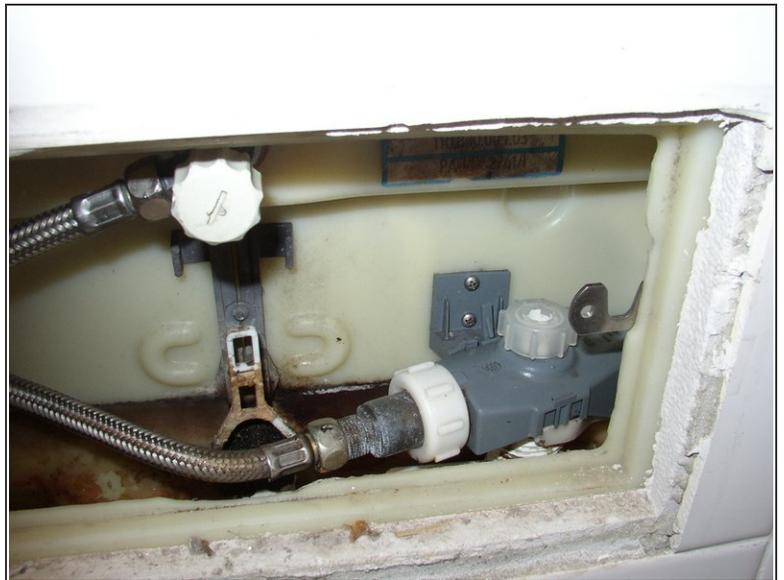
Step 4 — The valve

- The filling valve. Photo 1 with the surface box.
- Photo 2 shows the valve in the flush-mounted box.

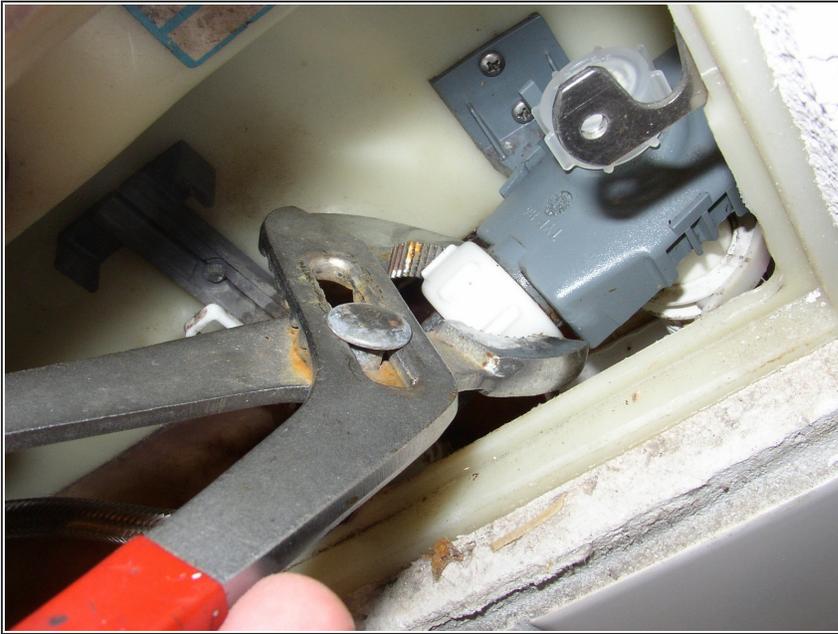
Step 5 — Disconnect water inlet

- With a water pump pliers, you loosen the union nut on the valve. So it is separated from the water inlet.
- Remove the hose slowly so that no part falls out.

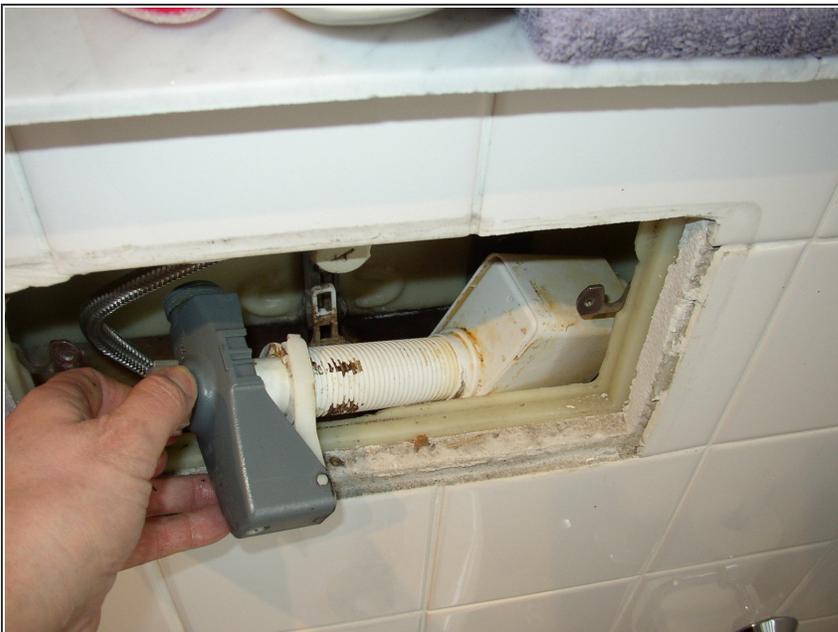
Step 6 — Lift out the valve

- With the surface-mounted box you can simply push the valve upwards.
- With the flush-mounted box, lift the valve upwards and set it aside. then push on the upper part until the float releases.
- Now you can lift out the parts.

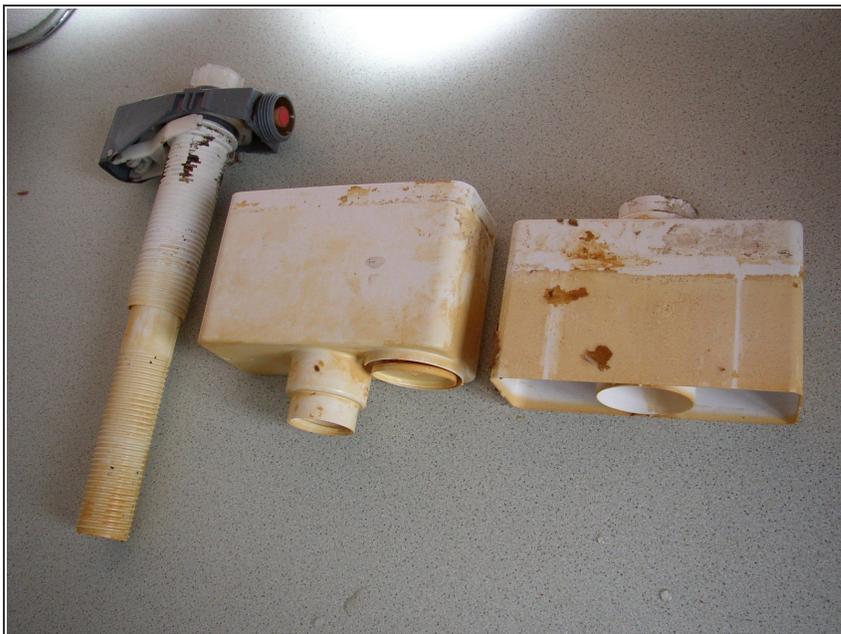
Step 7

- Here you can see the parts of the valve. The seal is the red dot!

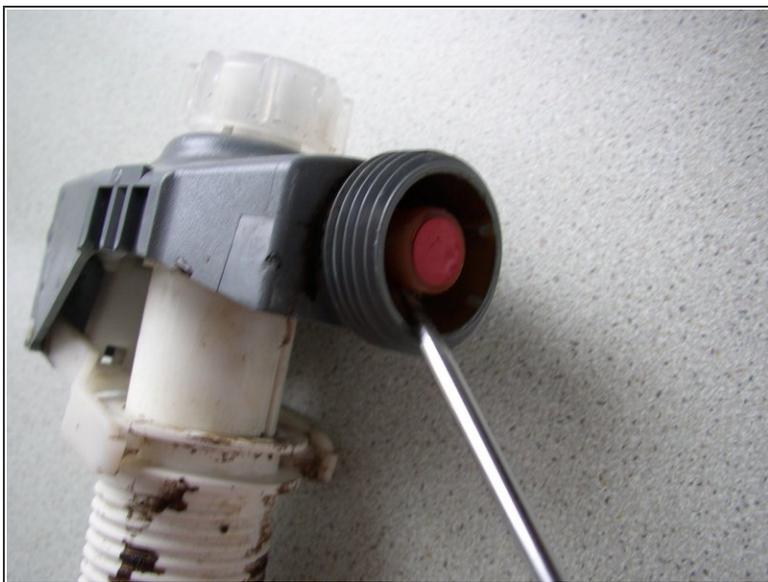
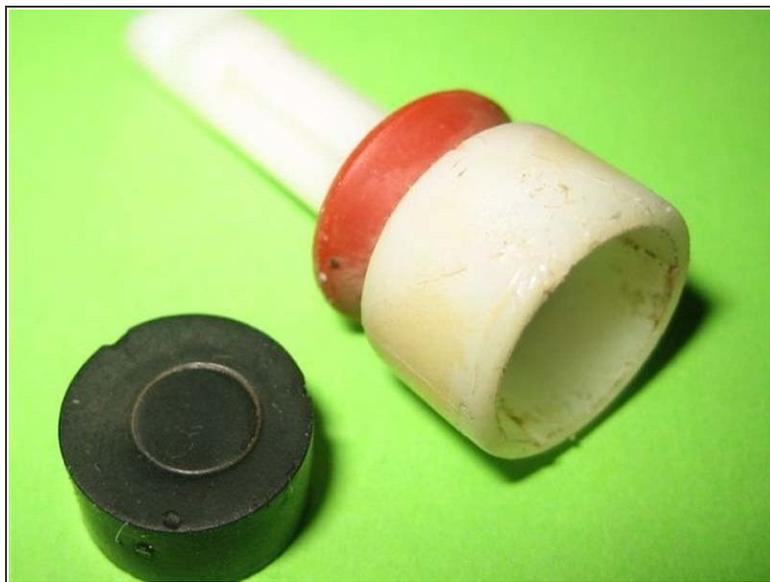
Step 8

- Now the seal has to be removed and replaced. It is sometimes difficult to find out. Try a small screwdriver.
- Figure 2 shows a defective seal (here black). Clearly a ring is pressed into it.
- ⓘ If the seal is still elastic, you can just flip it over. A new seal is really not expensive.

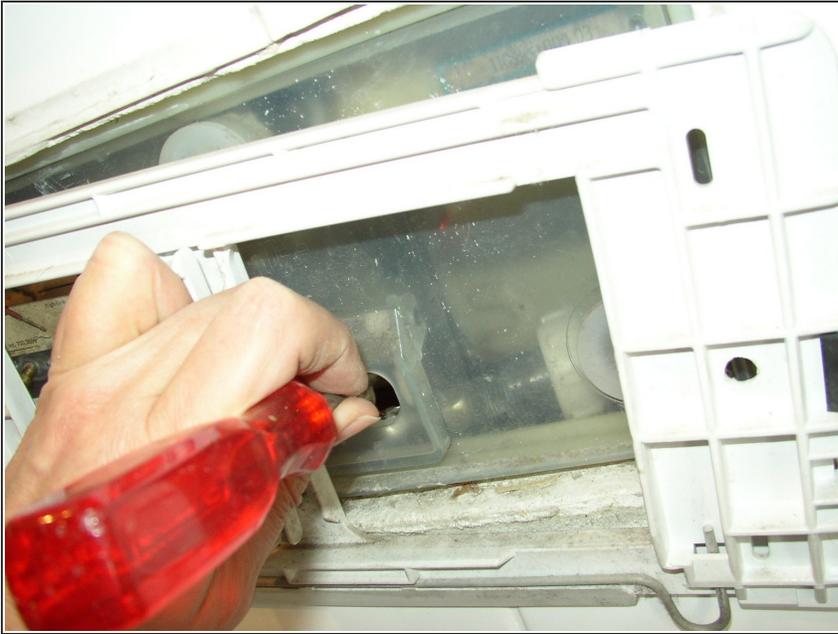
Step 9

- When reassembling you have to make sure that the release lever engages correctly again. Use a screwdriver if necessary.
