# Hamilton Beach 70730 Drive Shaft Replacement

Replace the drive shaft of your Hamilton Beach 70730 food processor.

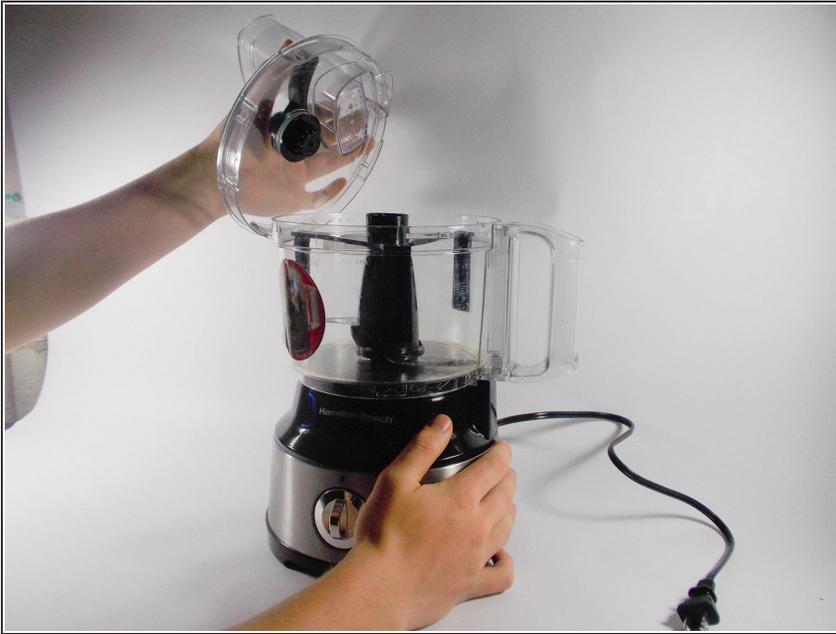
## Step 1 — Bowl

- Remove the cover by turning it in the counterclockwise direction.

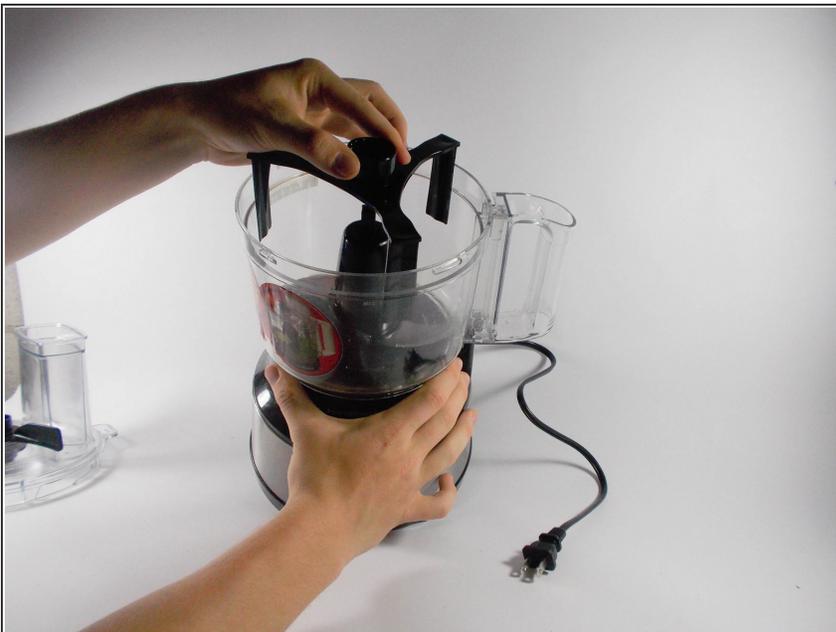
## Step 2

- Remove the bowl scraping mechanism by simply grabbing the middle section and lifting.

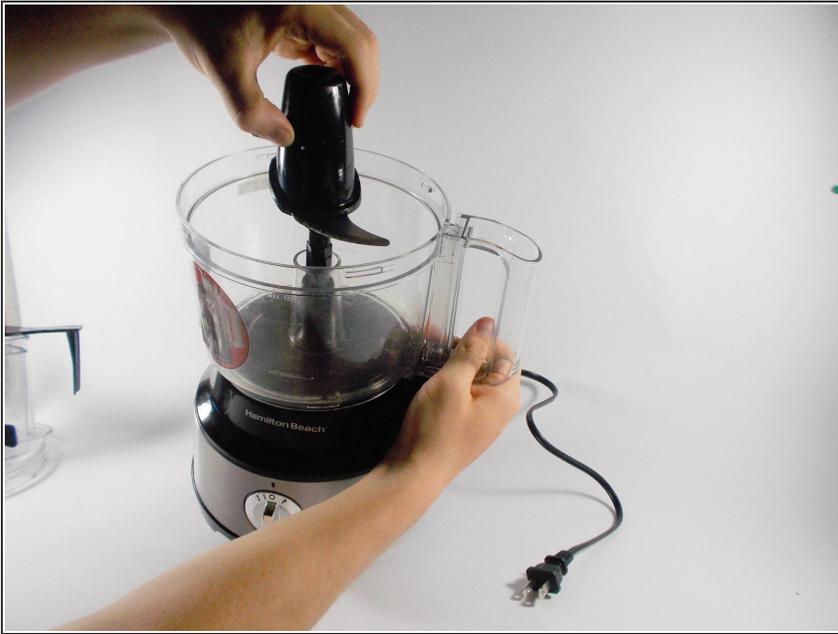
### Step 3

- Remove the blade mechanism by lifting it off of the blade shaft.

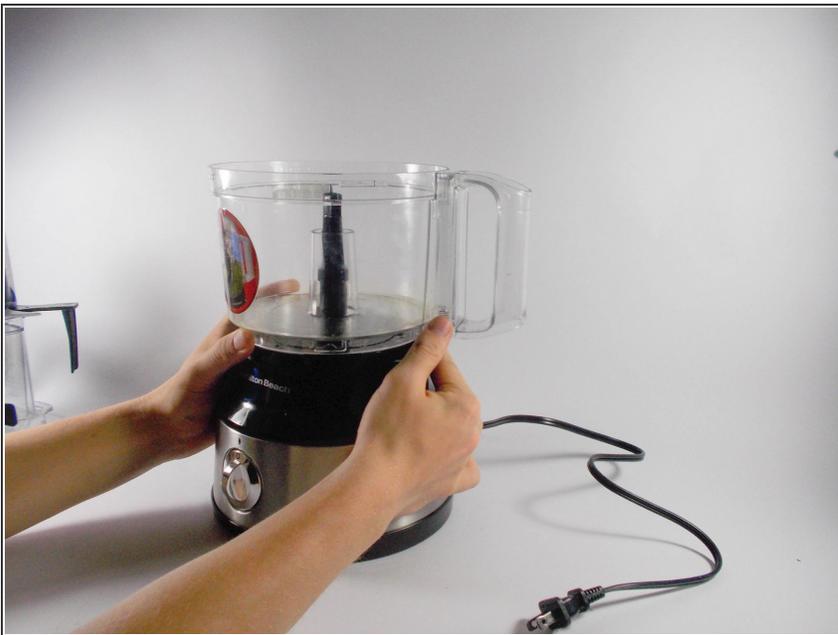
### Step 4

- Place hands on bowl and turn it gently, but firmly, counter-clockwise.

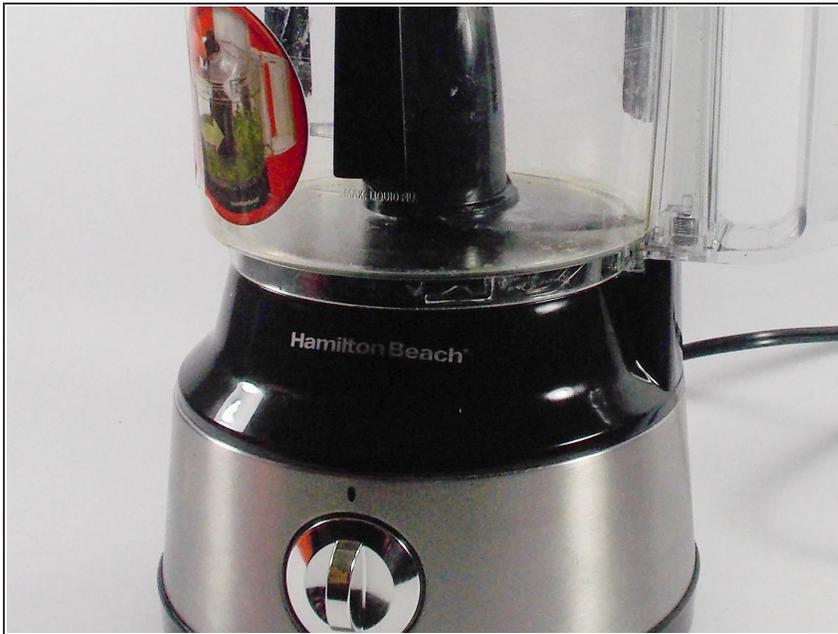
## Step 5

- i** Make sure there is no food or grime along the outside sides of the bowl or the base.

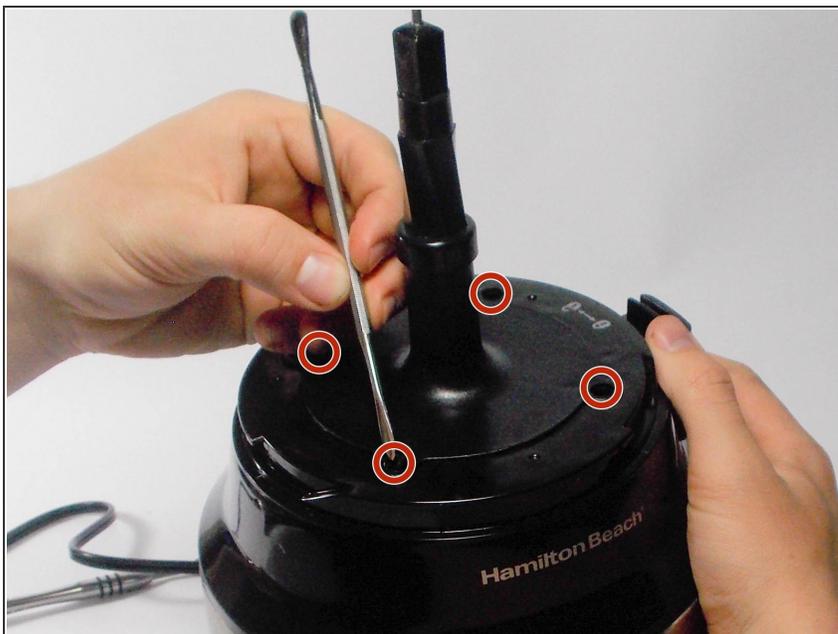
## Step 6 — Drive Shaft

- Using the metal spudger, remove the four adhesive plastic covers that hide the screws.
- i** These covers are adhered to the screws.

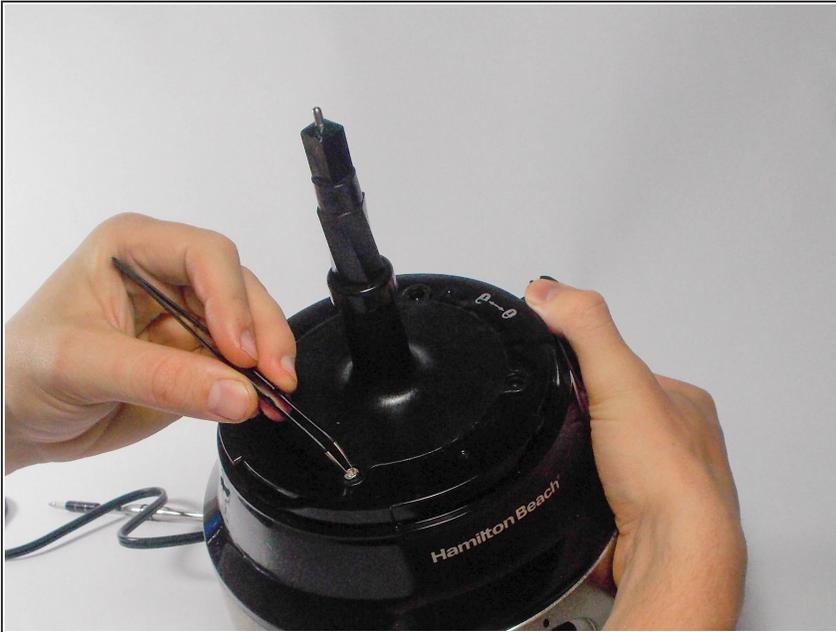
## Step 7

- Remove any access glue that is adhered to the screws with the precision tweezers.

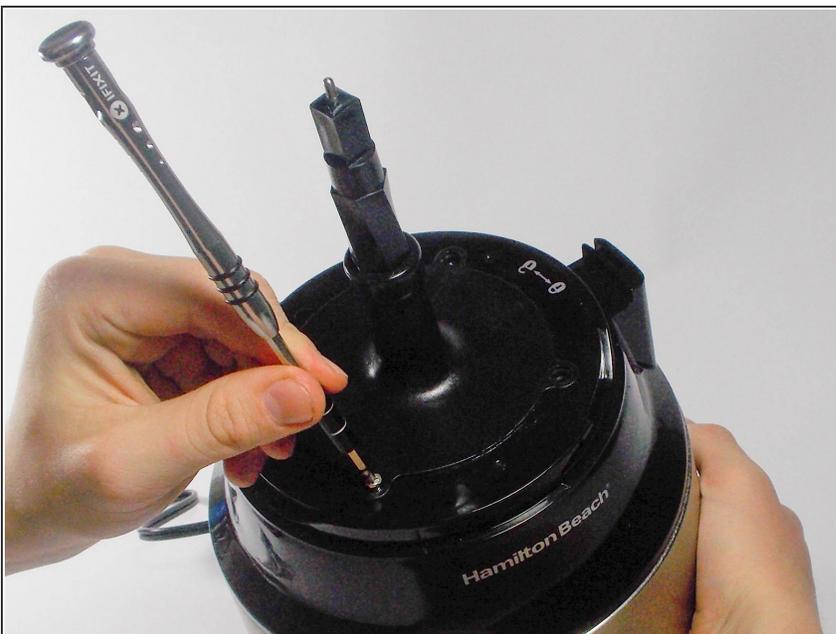
## Step 8

- Using a JIS #1 driver, remove the four 10 mm screws.

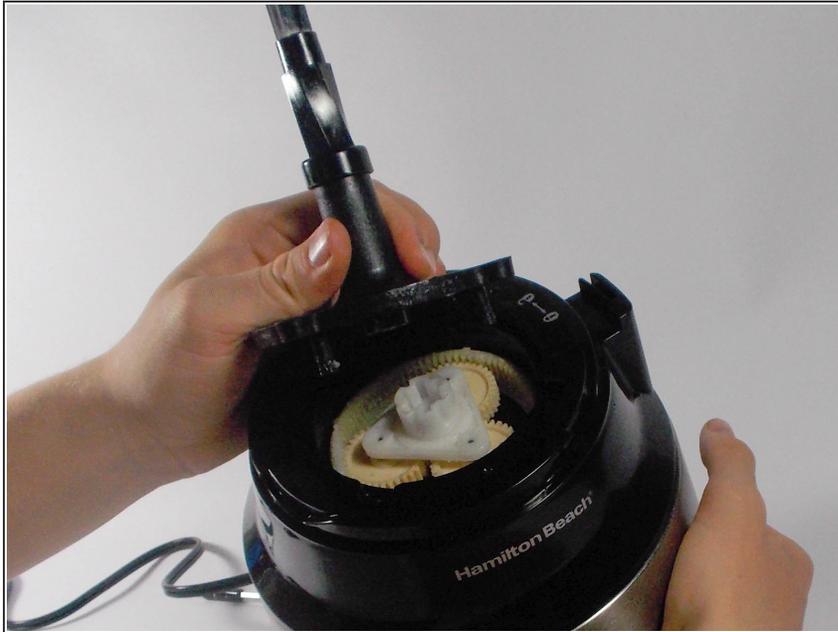
## Step 9

- Lift the drive shaft.

To reassemble your device, follow these instructions in reverse order.
