# Lenovo Yoga 910-13IKB USB Ports Replacement

How to replace the USB ports in the Lenovo Yoga 910-13IKB.

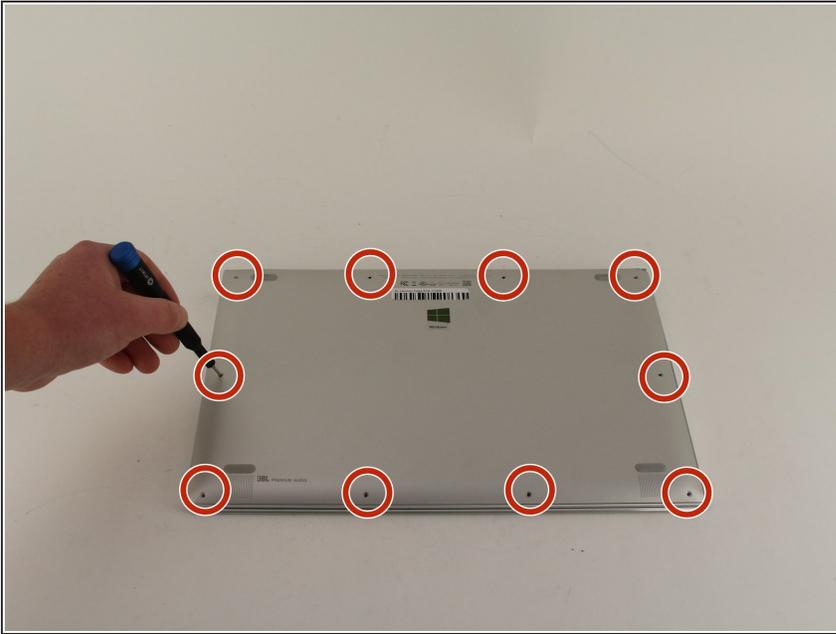
## Step 1 — Battery

- ⚠ Completely power off the laptop and disconnect it from any power sources before beginning.
- Turn the laptop over and remove the ten 3mm JIS #00 screws along the perimeter of the bottom panel.
- Remove the panel.

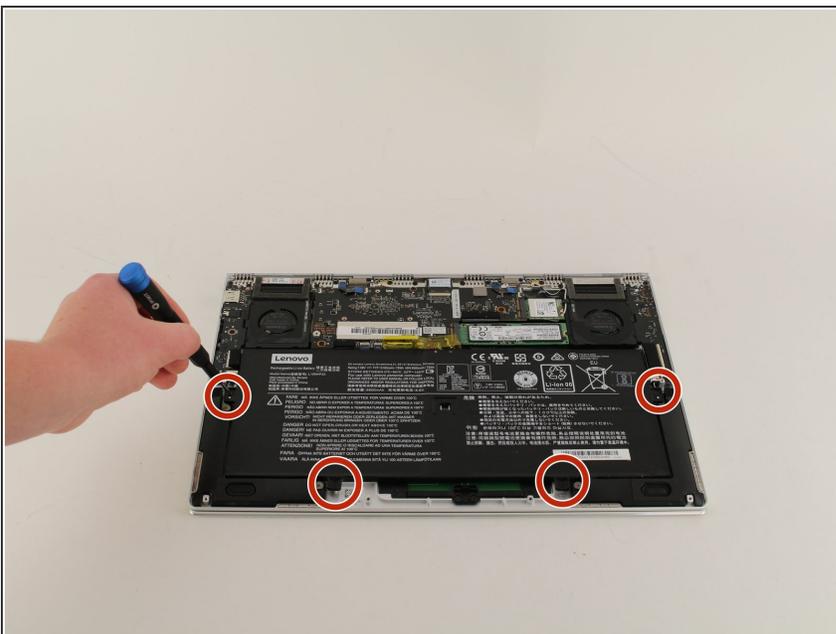
## Step 2

- Remove the four 3mm JIS #00 screws holding the battery in place.

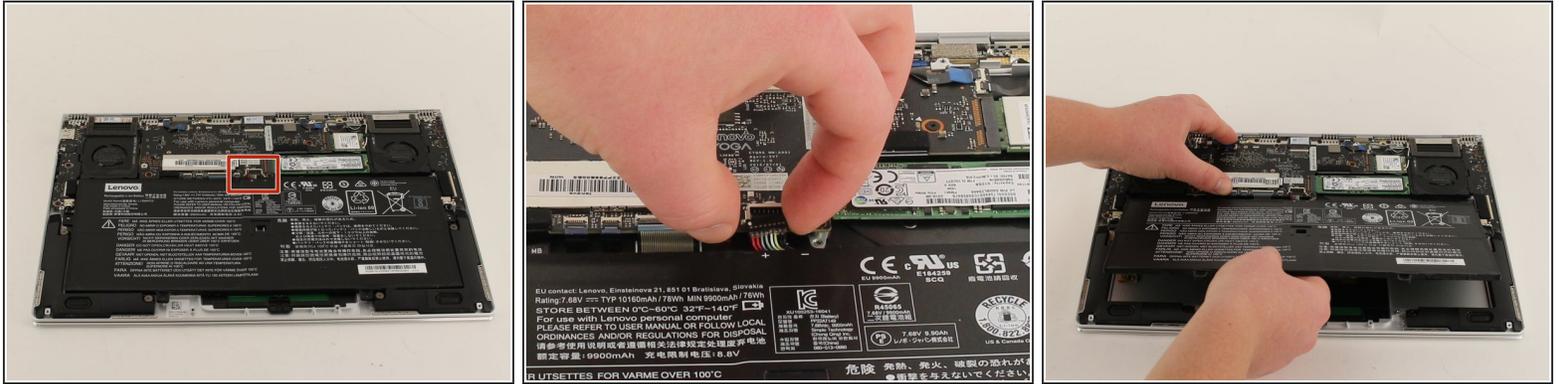
## Step 3

- Disconnect the bundled cable connector that allows the battery to power the device.
- ⚠ Pull evenly on the width of the cable so that no individual wire is overly strained.
- Lift the battery out.

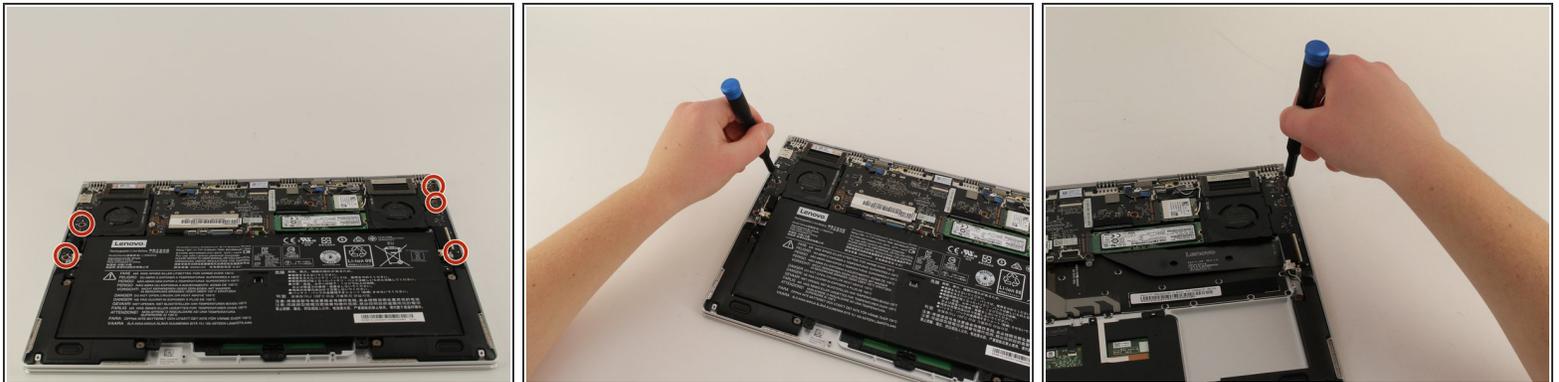
## Step 4 — USB Ports

- Remove the five 3mm JIS #00 screws holding the array of ports in place.

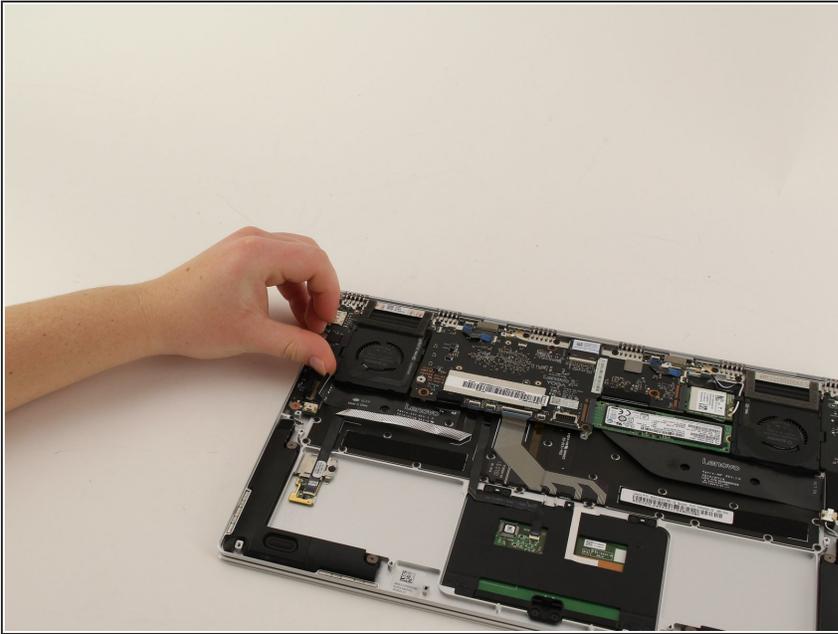
## Step 5

- Lift up on the cover on top of the ribbon connector and gently pull the ribbon cable out.

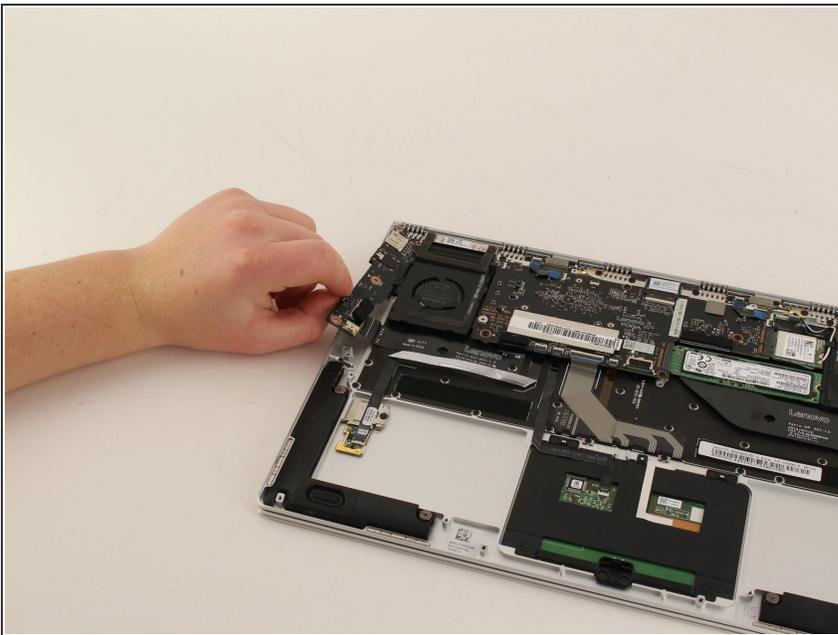
## Step 6

- Lift up on the component and remove it.

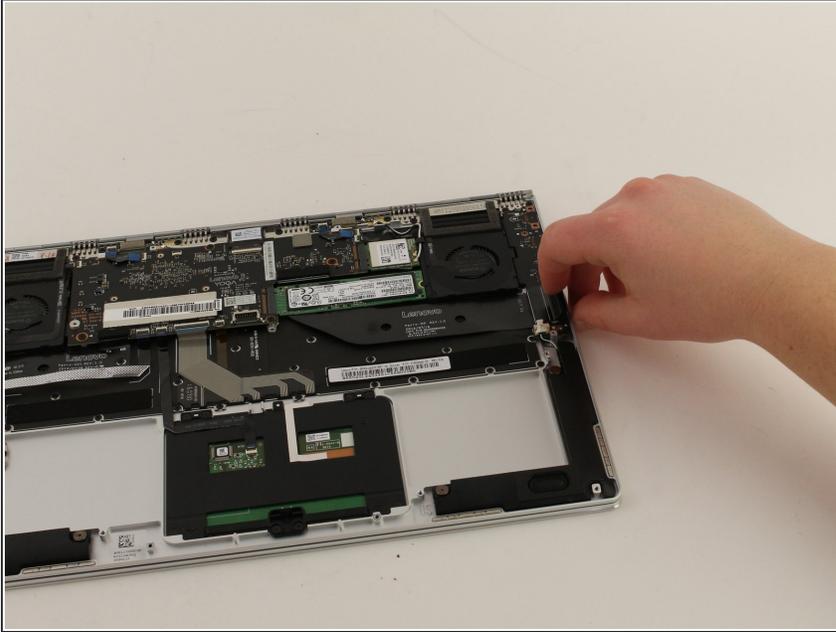
## Step 7

- Repeat the same process on the opposite side, lifting up on the connector cover and pulling the ribbon cable out of its place.

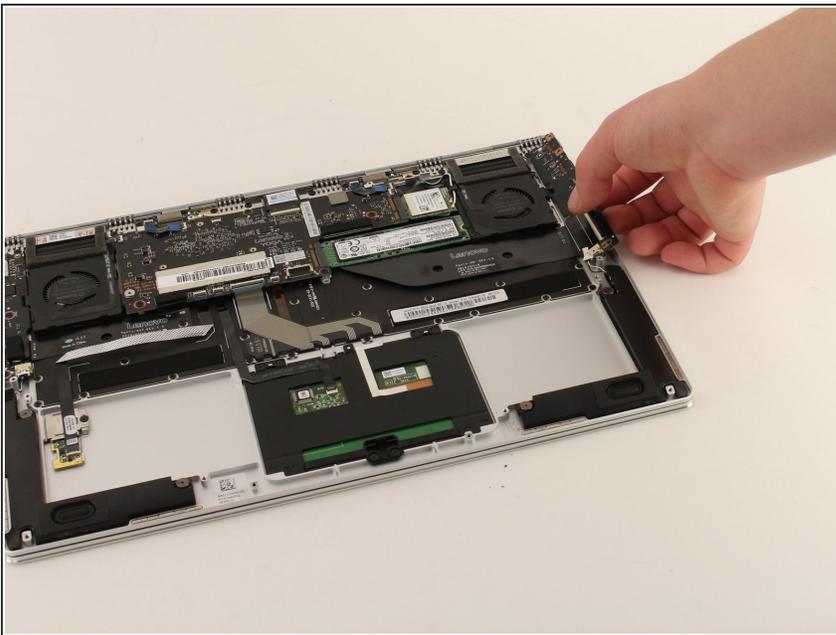
## Step 8

- Lift up on the set of ports and remove it from the device.

To reassemble your device, follow these instructions in reverse order.
