Macintosh IIsx Hard Drive Replacement

Written By: Chris Green

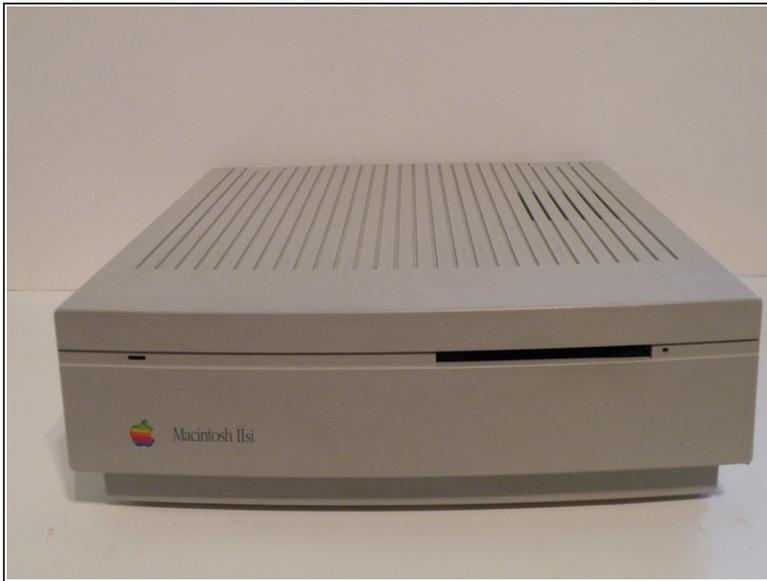
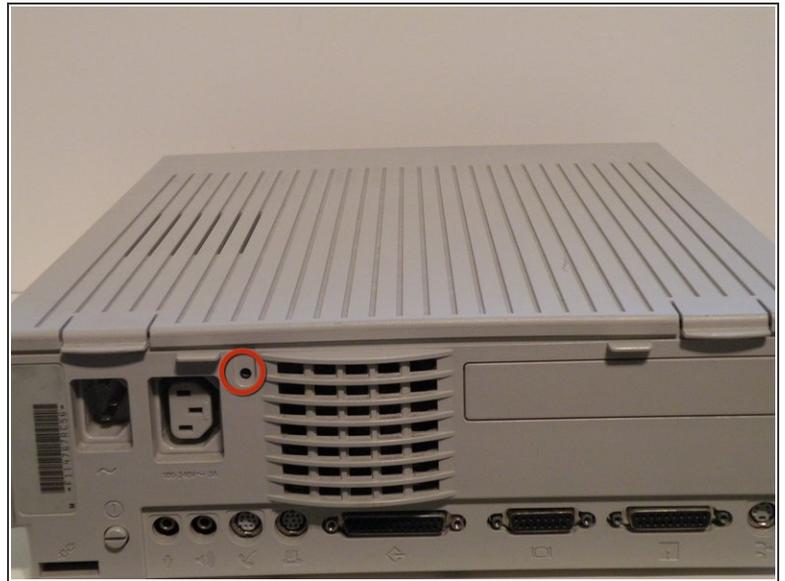
Step 1 — Top Case

- Start by turning the computer around, and remove this #0 Phillips Screw.
- ⓘ There may or may not be a Phillips #0 screw here, depending on whether or not the computer has ever been serviced.

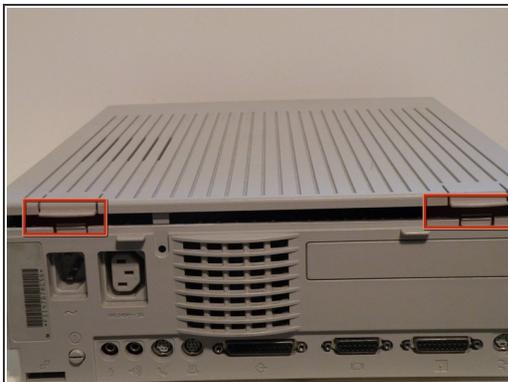
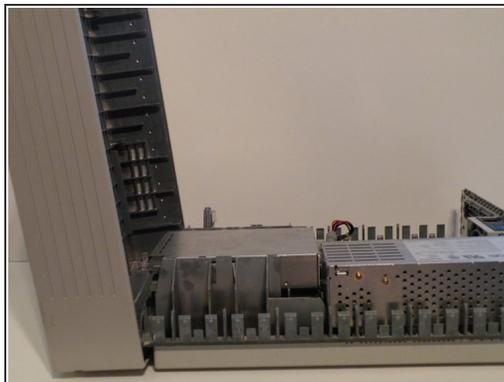
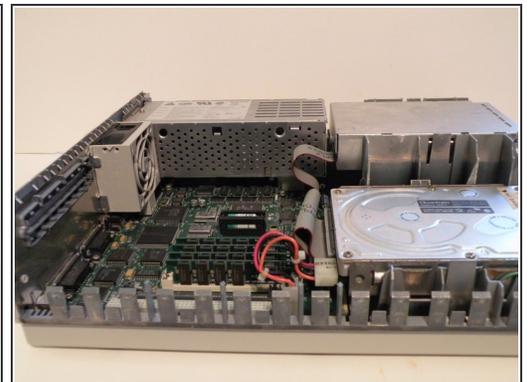
Step 2

- Now lift these two clips, and slowly pivot the case up.
- You can now separate the top of the computer from the rest of the machine.

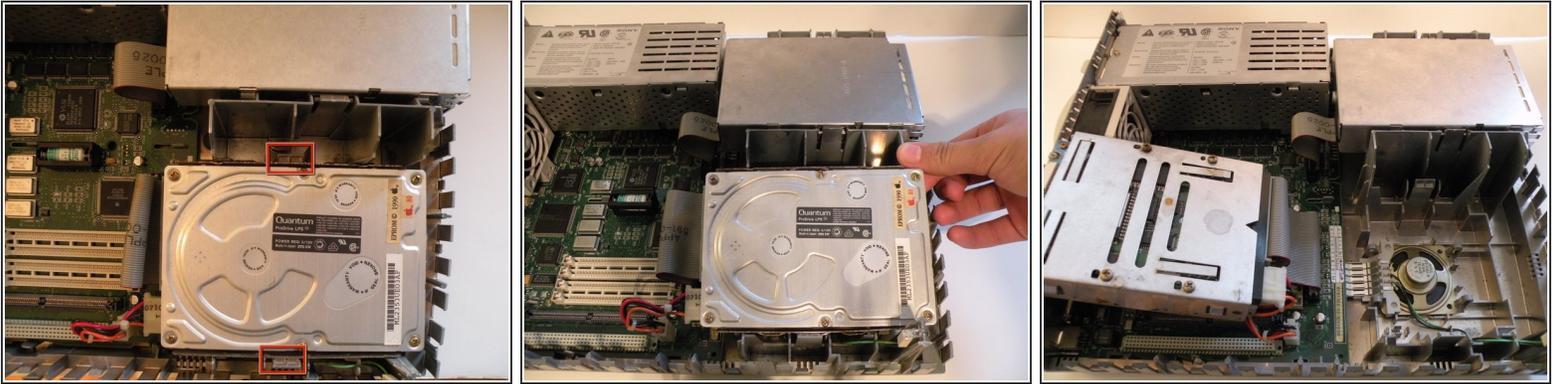
Step 3 — Hard Drive

- The Macintosh IIsx's hard drive is located adjacent to the ram and floppy drive.
- Start by pushing these two tabs out, and lifting the drive up.
- Then, flip the drive over, and remove the connection cables.

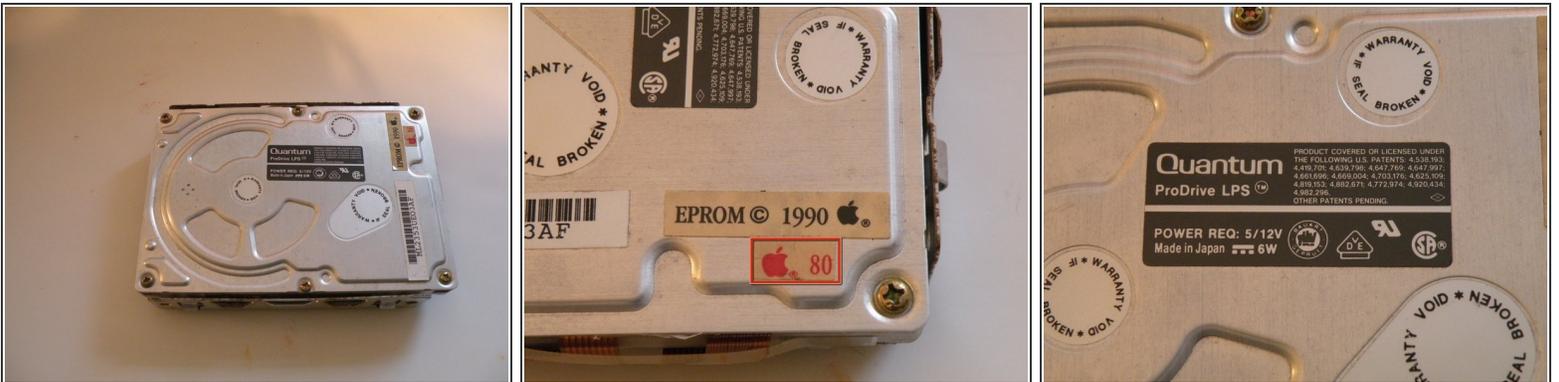
Step 4

- The hard drive: A Quantum ProDrive LPS, made in 1990, and surprisingly, it still works!
- This drive has an 80MB capacity, not very large by today's standards, but not bad way back then...
- Believe it or not, hard drive construction hasn't changed much in the last 20 years. Other than a few new interfaces, the form factor, 3.5" width and 4-Pin 12V/5V power connector has stayed the same.
