# Microsoft Lumia 535 Loudspeaker ,Vibra Motor or Camera Light Replacement

Microsoft Lumia 535

RM-1090 / RM-1091/ RM-1089 / RM-1092

How to disassemble the phone and replace the Loudspeaker or Vibration motor.

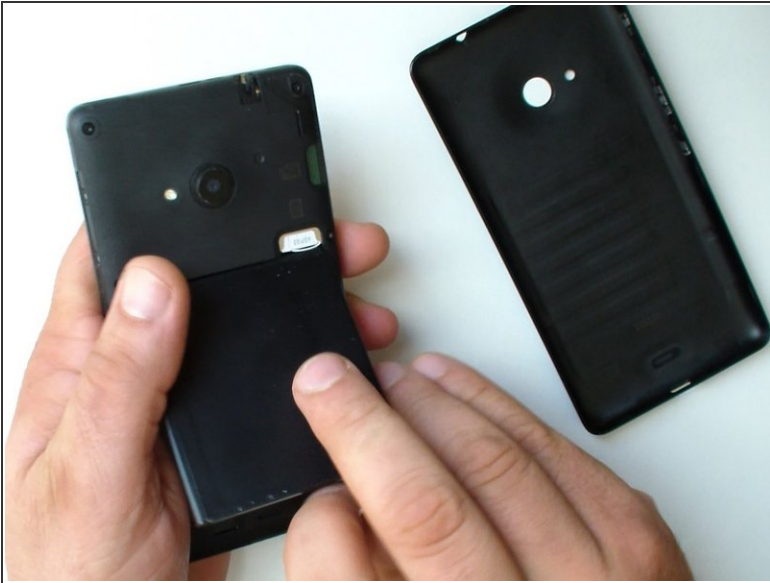
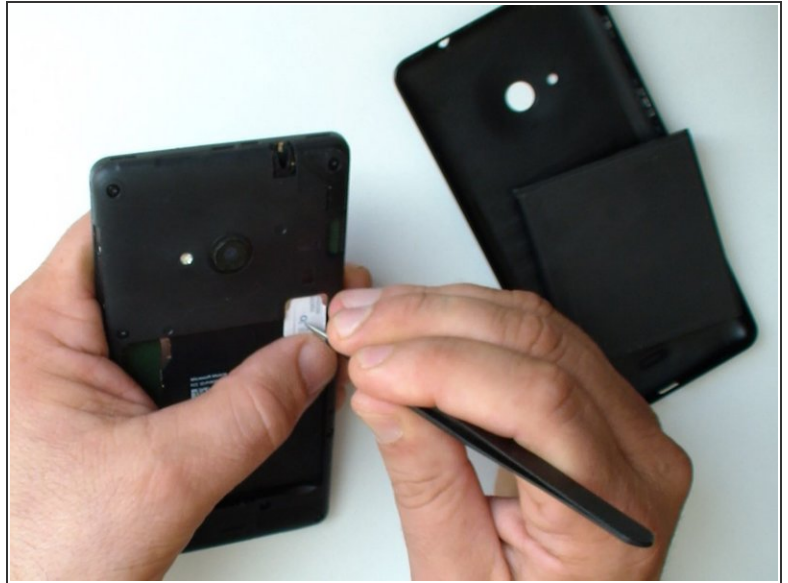
## Step 1 — Back Cover / Rear Case

- Turn off the phone.
- Remove the battery and any SIM and memory cards.

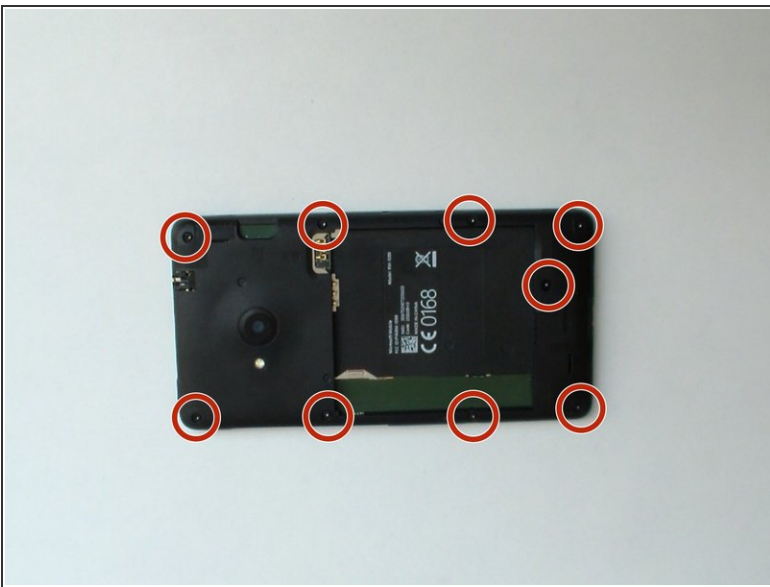
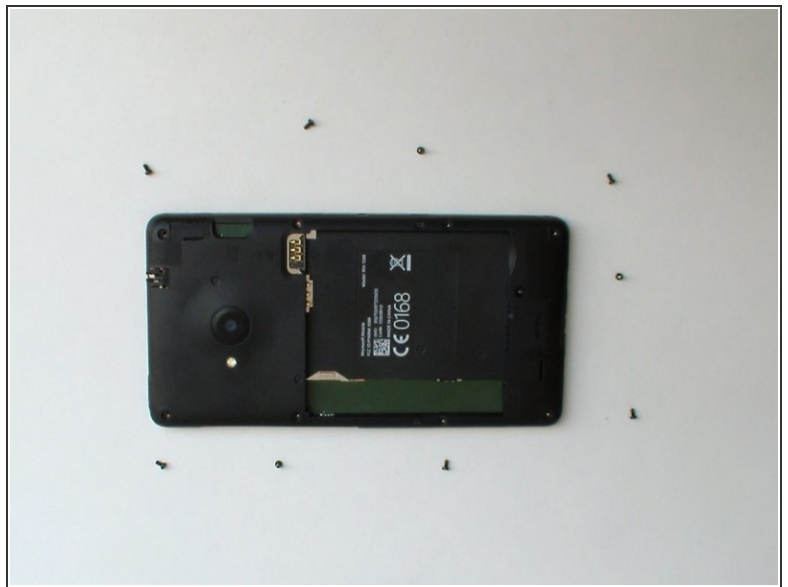
## Step 2

- With a screwdriver Torx T4 remove the 9x screws.

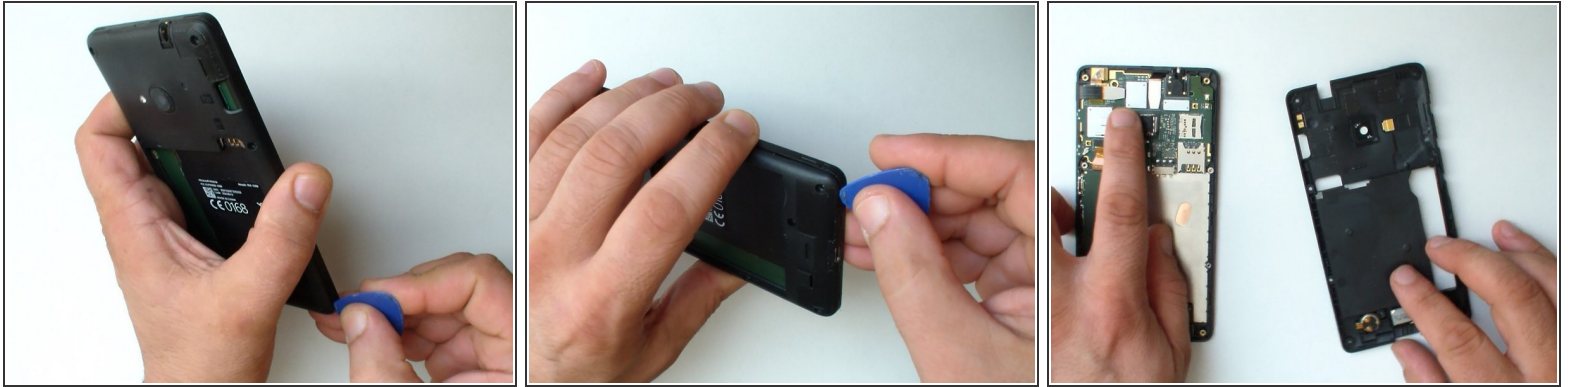
### Step 3

- With a plastic opening tool separate the back cover from the middle frame.

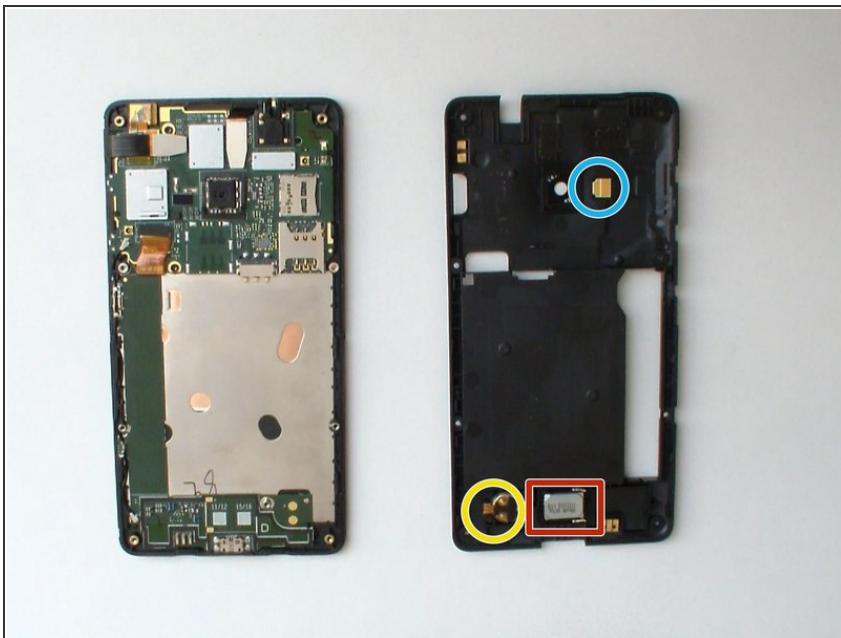
### Step 4 — Loudspeaker and Vibra Motor

- Loudspeaker
- Vibration motor
- Camera light

To reassemble your device, follow these instructions in reverse order.
