Midland X-tra Talk Radio LXT118 Front buttons Replacement

Front buttons stuck or misaligned? Let's get them readjusted!

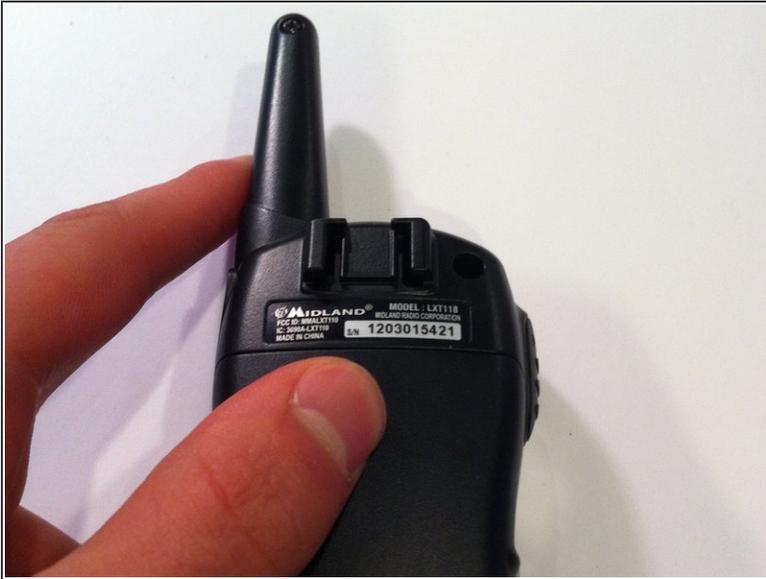
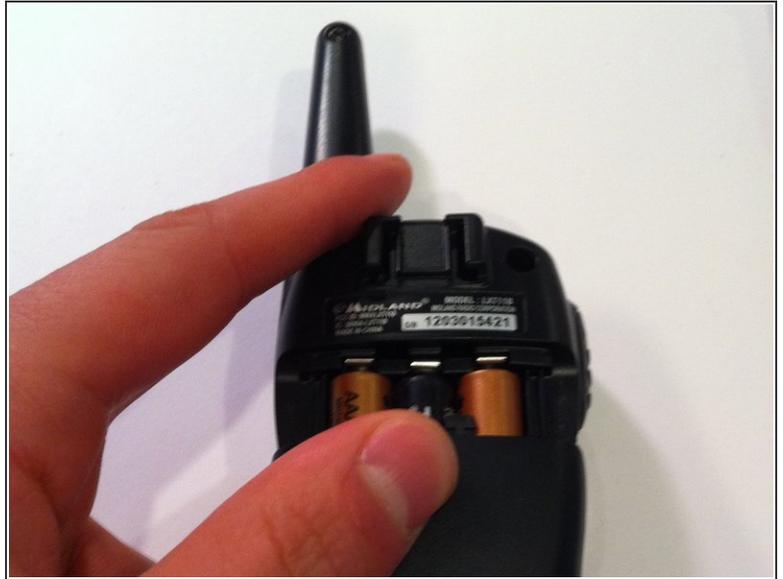
Step 1 — Disassembling Midland X-tra Talk Radio LXT118 Batteries

- First, apply pressure with your thumb on the top of the battery cover.
- Next, pull down on the cover until it begins to slide.

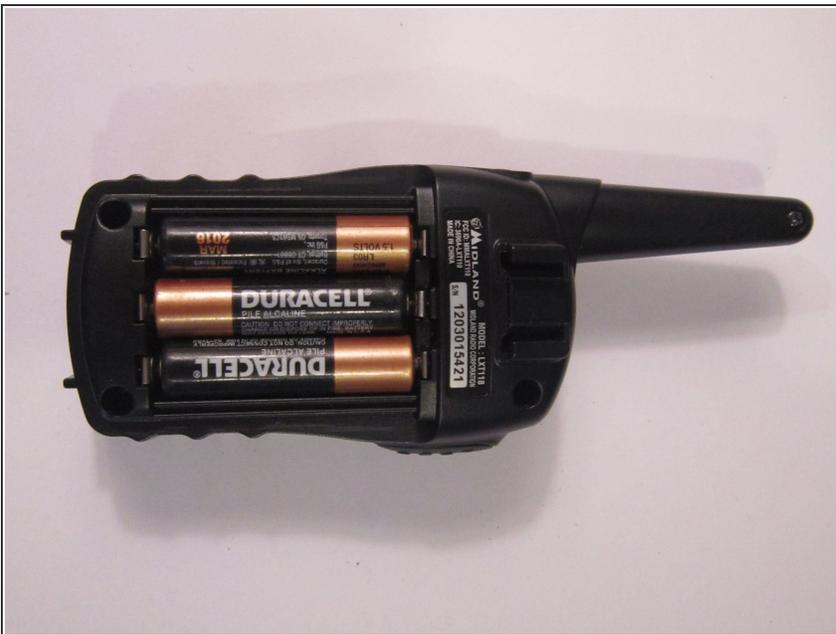
Step 2

- Finally, once the cover is completely off, pry up the old batteries with your finger or a strong, skinny tool (i.e. spudger).

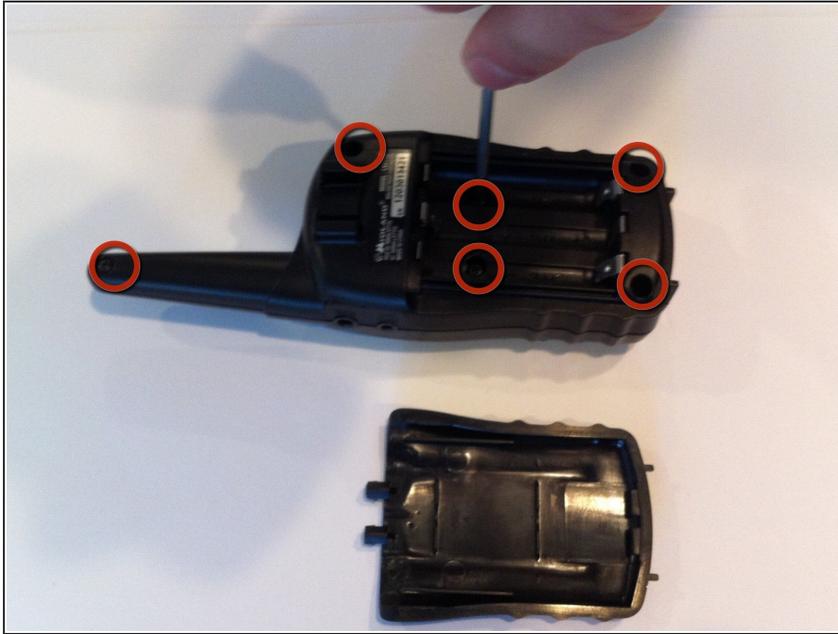
Step 3 — Case

- Unscrew the six 8.0 millimeter long, #0 screws on the backside of the case using the Phillips #0 screwdriver.

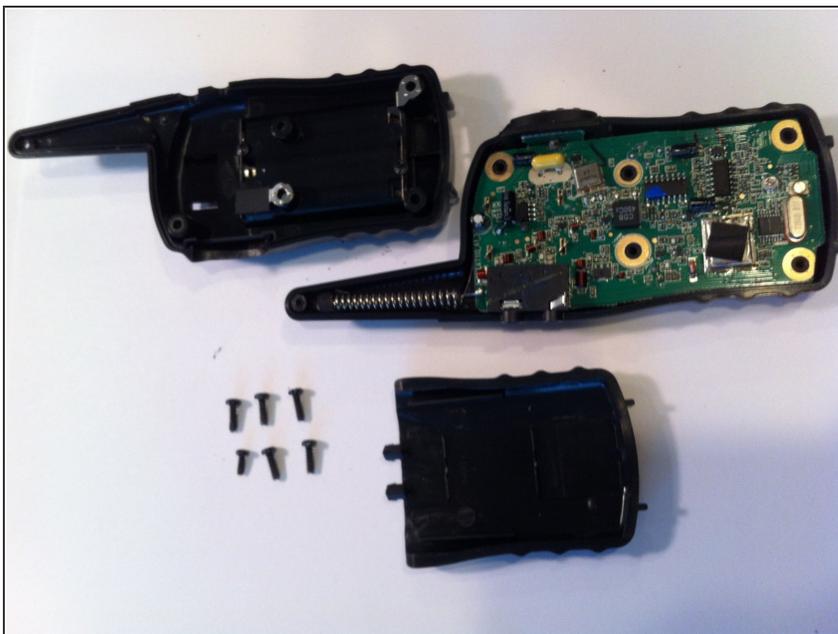
Step 4

- Detach back part of the case by gently lifting up.

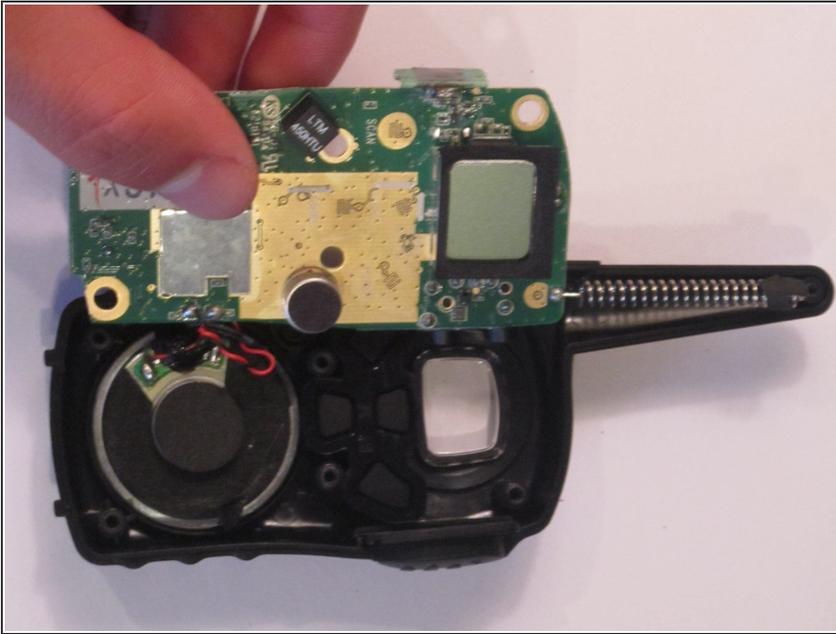
Step 5 — Front buttons

- Once the back case is already off, use your fingers to lift up the circuit board from the side opposite the antenna.

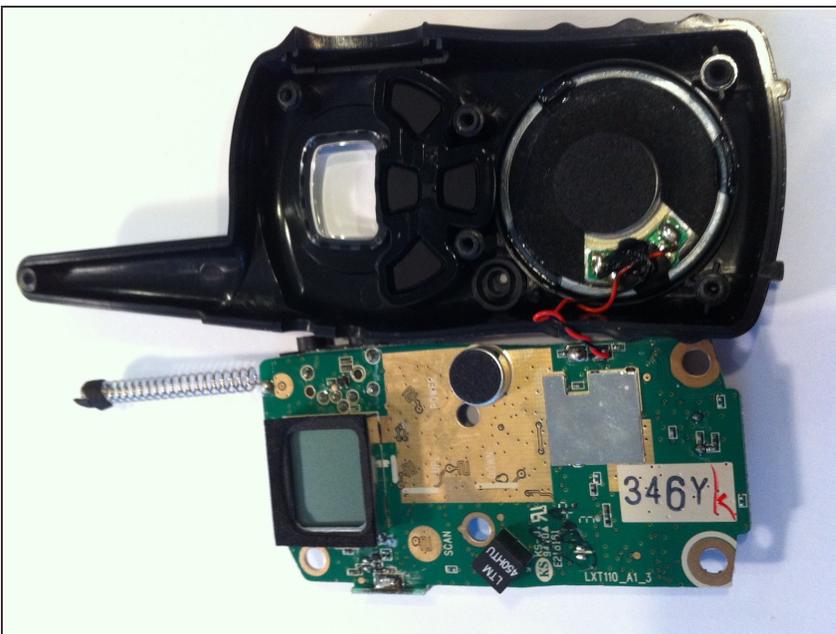
Step 6

- Lay the circuit board down on the side, as you will not want it interfering with your work on the buttons!

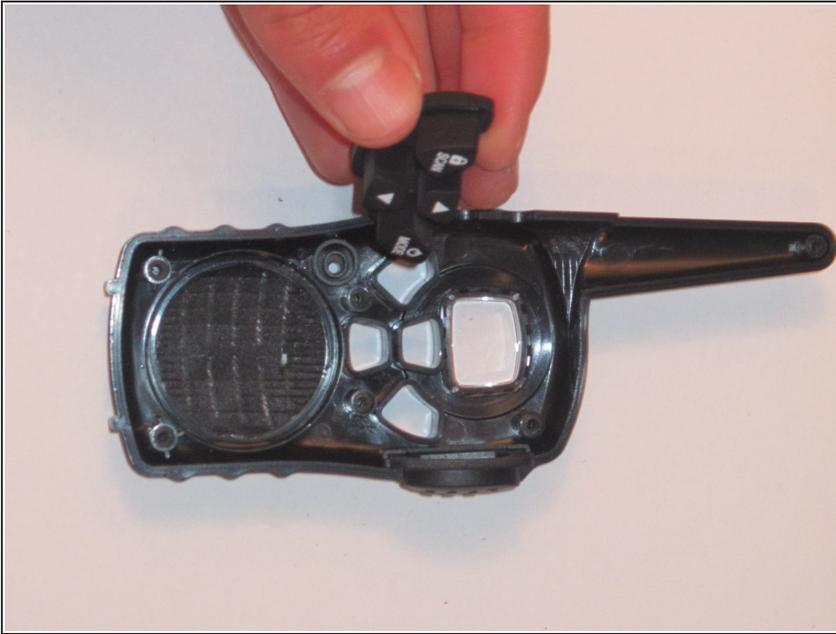
Step 7

- Grasp the rubber cast around the buttons from one side, and slowly lift upwards. Make note of which way the buttons fit into the plastic casing!
- At this point, the buttons can be cleaned in accordance with the [radio buttons are stuck or sticking](#) troubleshooting guide.
- ⓘ The speaker does not need to be removed in order to get to the buttons.
