Oster Blend-N-Go My Blend Blade Assembly Seal Replacement

Replace damaged blade assembly seal.

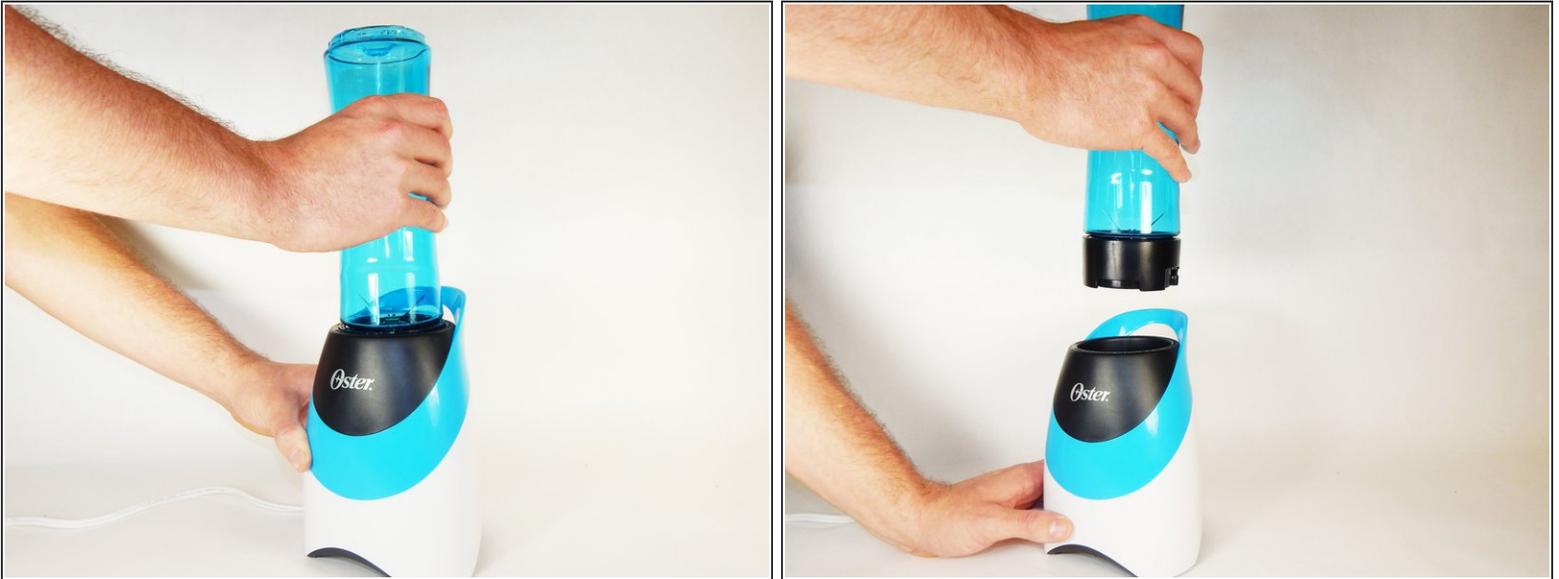
Step 1 — Blender Bottle

- Grip the blender base with one hand and blender bottle with the other hand.
- Rotate the blender bottle a quarter turn counterclockwise .
- Lift the blender bottle out of the blender base. The blade assembly should still be attached to the blender bottle.

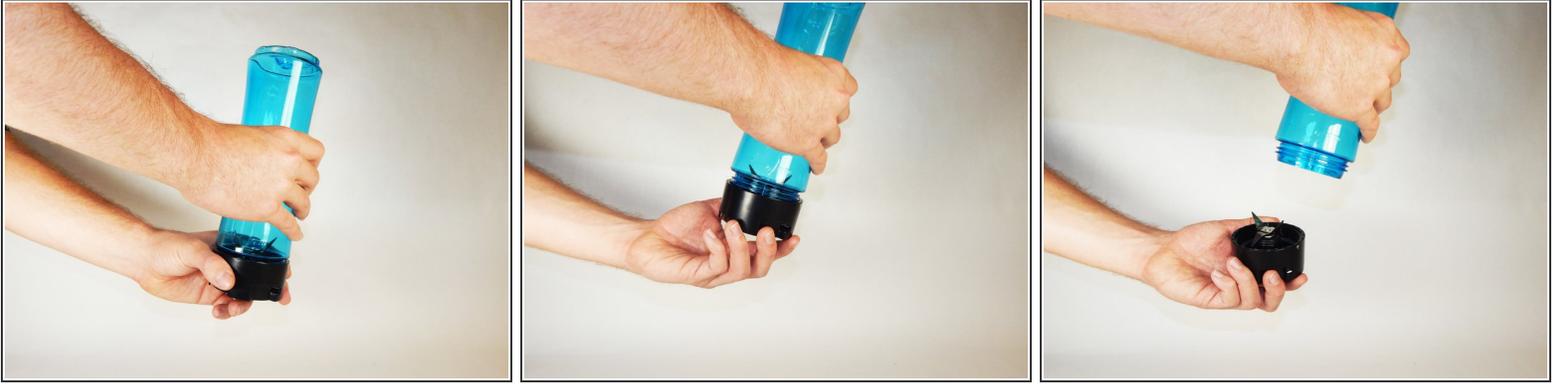
Step 2

- Grip the blade assembly with one hand and blender bottle with the other hand.
- Rotate the blade assembly counterclockwise until it is completely unscrewed from the blender bottle.
- Lift the blender bottle to separate it from the blade assembly.

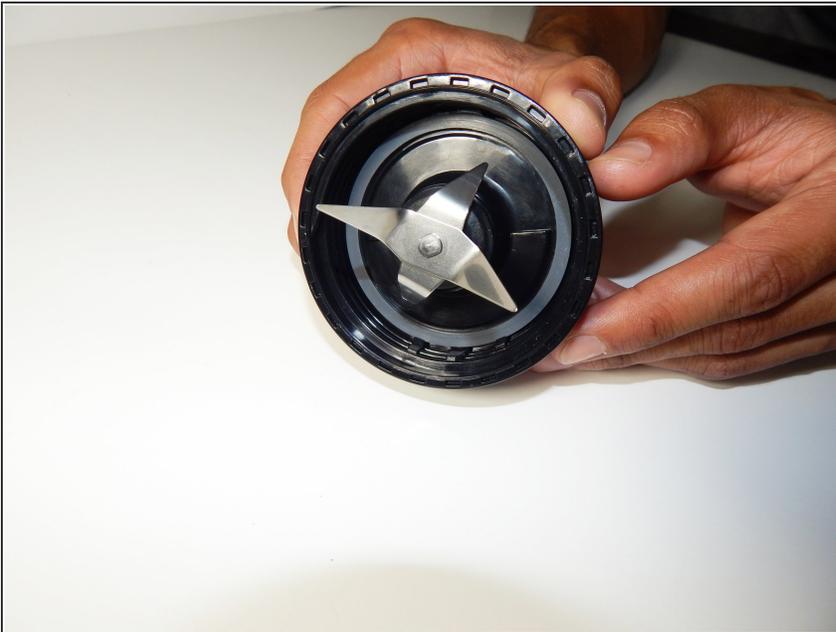
Step 3 — Blade Assembly

- After removing the blade assembly from the blender bottle, ensure your blade assembly has its seal placed in the seal bed.

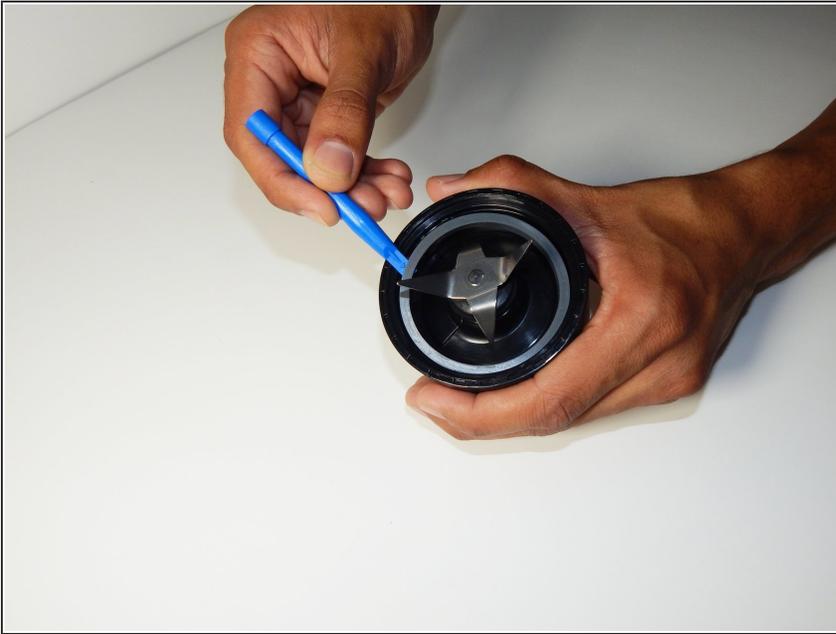
Step 4 — Blade Assembly Seal

- After separating the blade assembly from the blender bottle, position the plastic opening tool on either side of the seal in the blade assembly.
- Wedge tool between seal and seal seat wall.

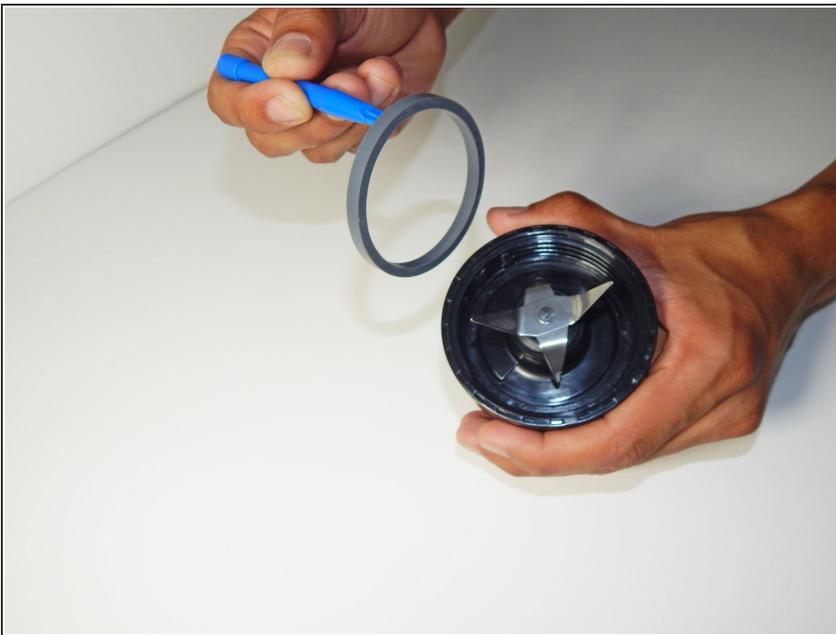
Step 5

- Gently pry the seal up while lifting seal out of the seal seat.

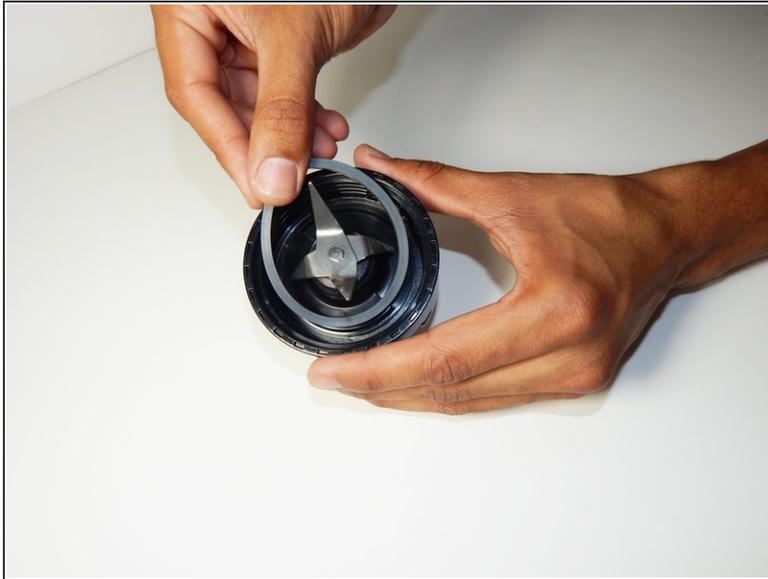
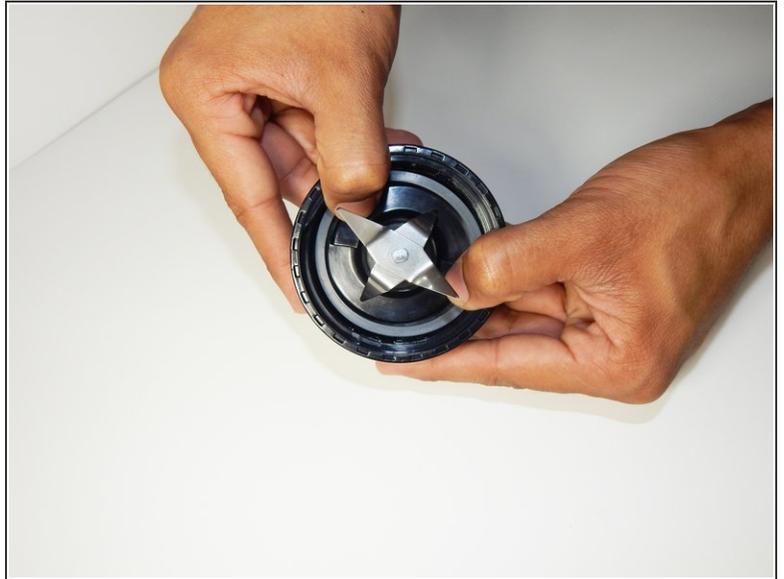
Step 6

- Place and press the new seal into seal seat with finger.
