Ryobi P271 Drill Bit Holder Replacement

This guide shows how to fix the drill bit holder on the Ryobi P271.

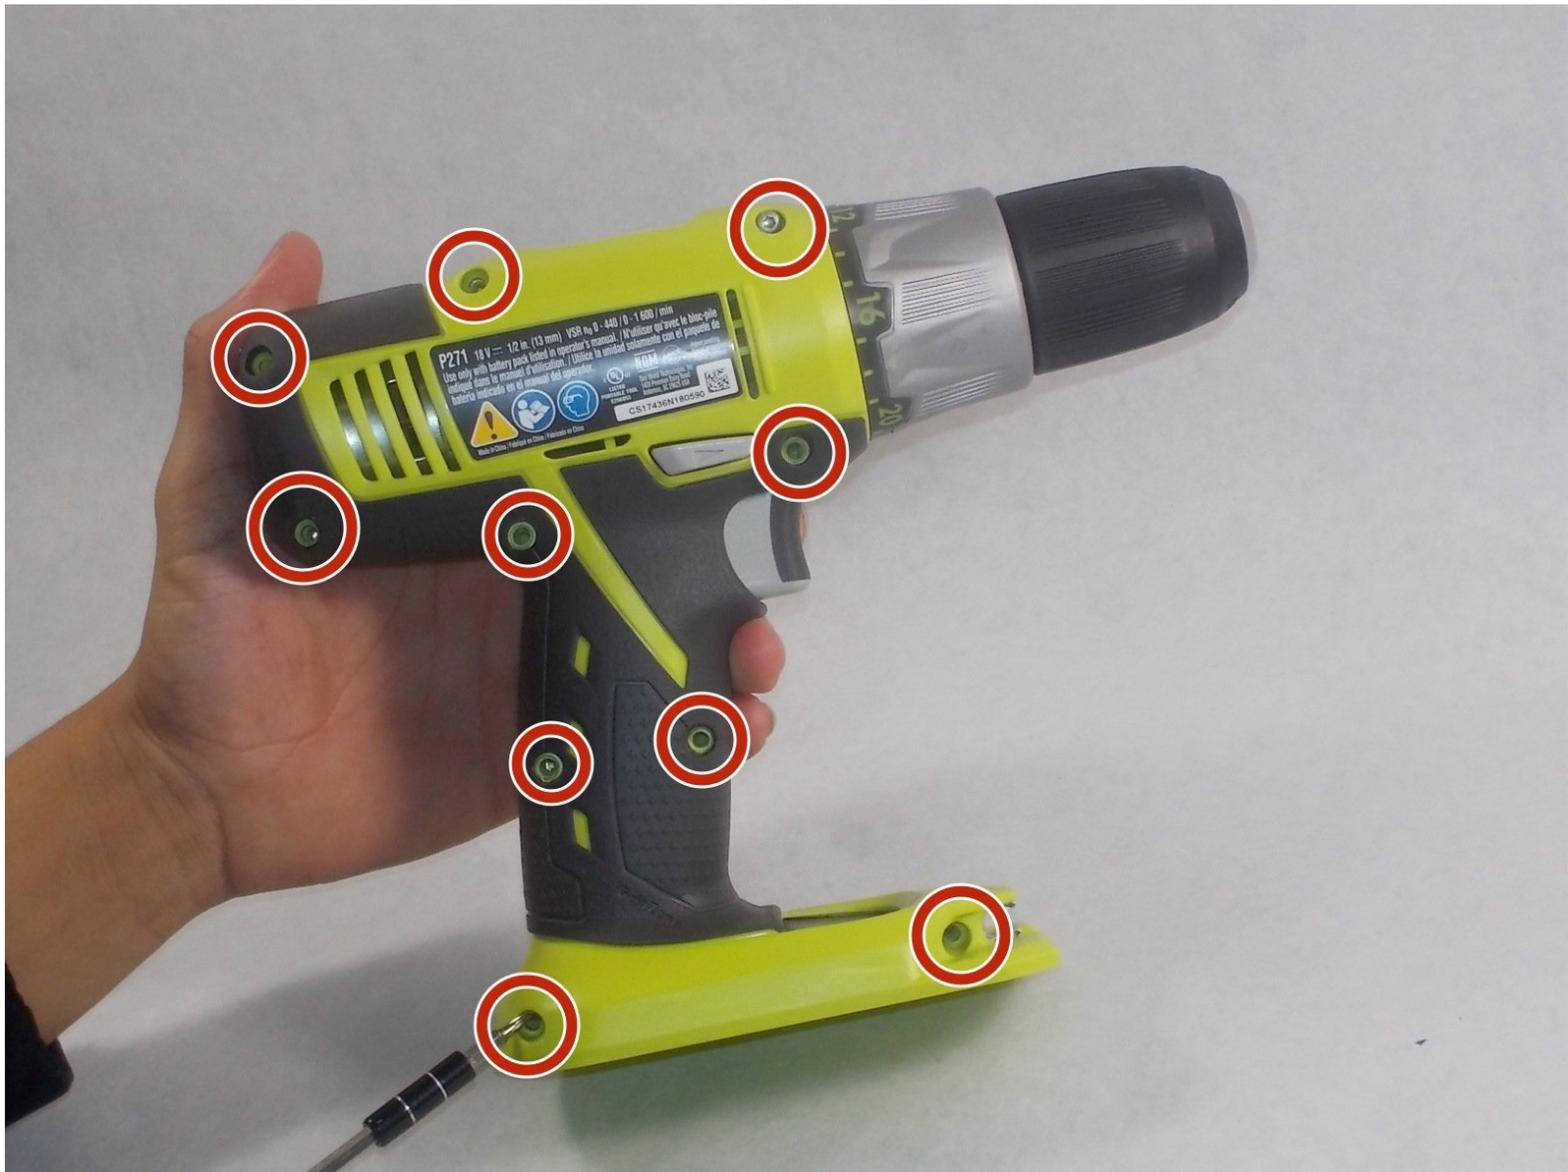
This guide shows how to fix the drill bit holder for the Ryobi P271. The clamps may be too tight or loose. You can adjust the tightness of the drill bit holder by turning the chuck. Turning the chuck right will tighten the clamps while turning them left will loosen them. Make sure your clamps are adjusted properly so that it may fit your drill bit.

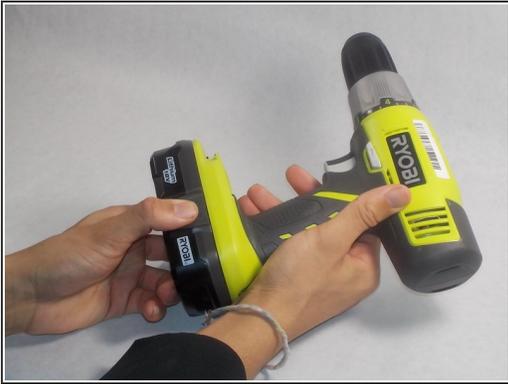
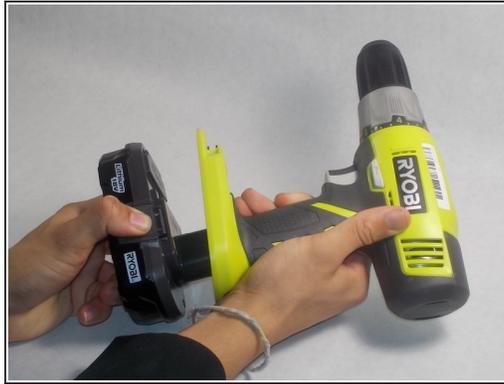
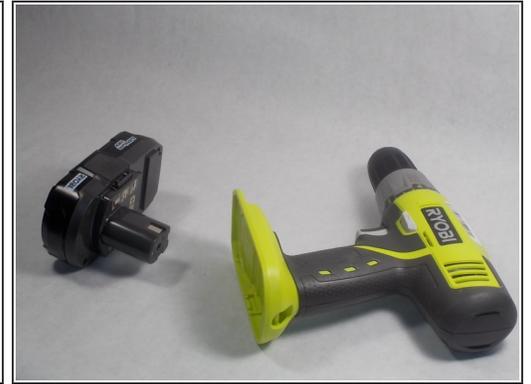
Step 1 — Battery

- Detach the battery unit from the drill body by pressing the battery release buttons on both sides of the unit and pulling outwards.

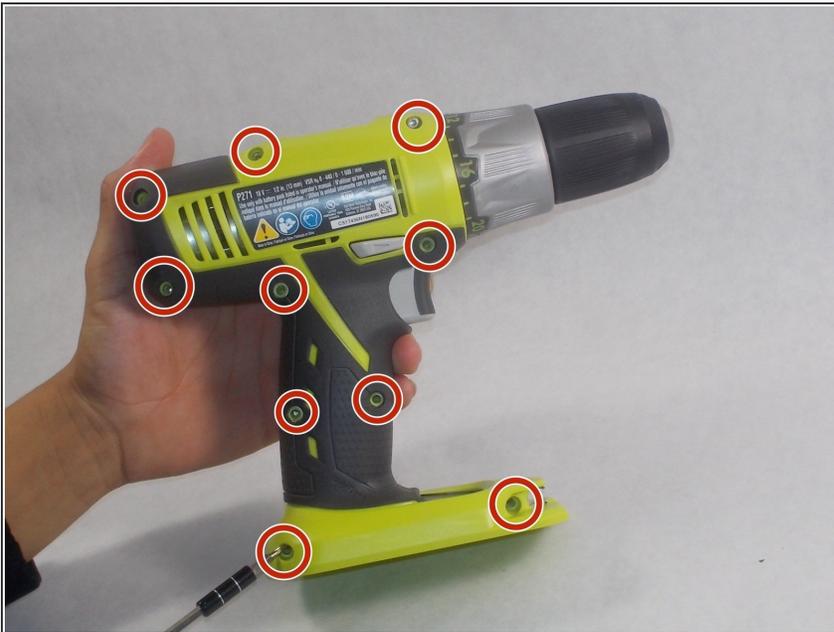
Step 2 — Drill Bit Holder

- Remove all ten screws from the drill's casing to gain access to the interior.

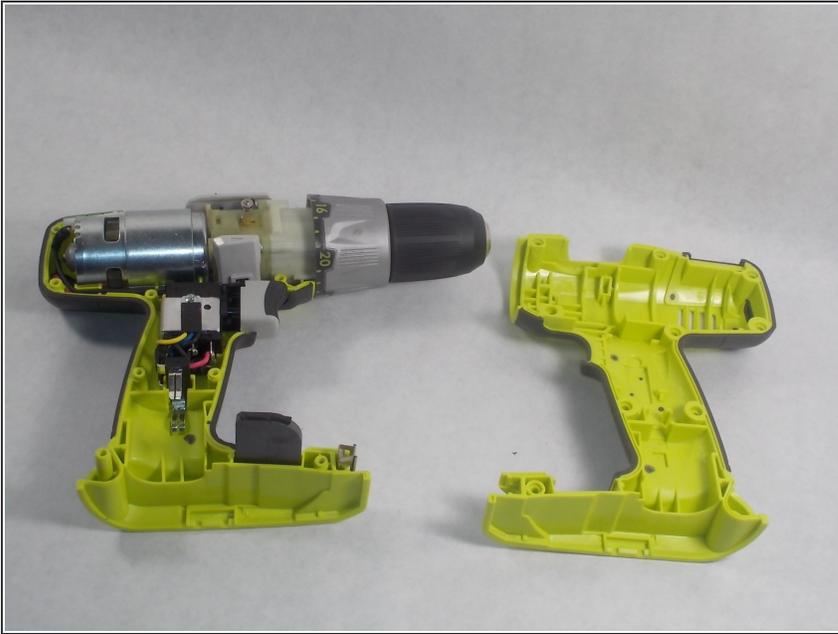
Step 3

- Using your hands, lift and remove the right cover of the drill body off from the left side and place it down.

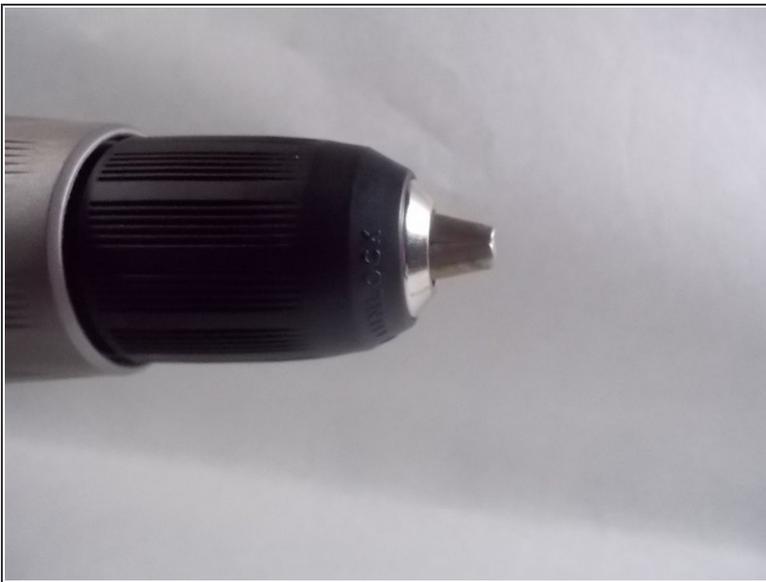
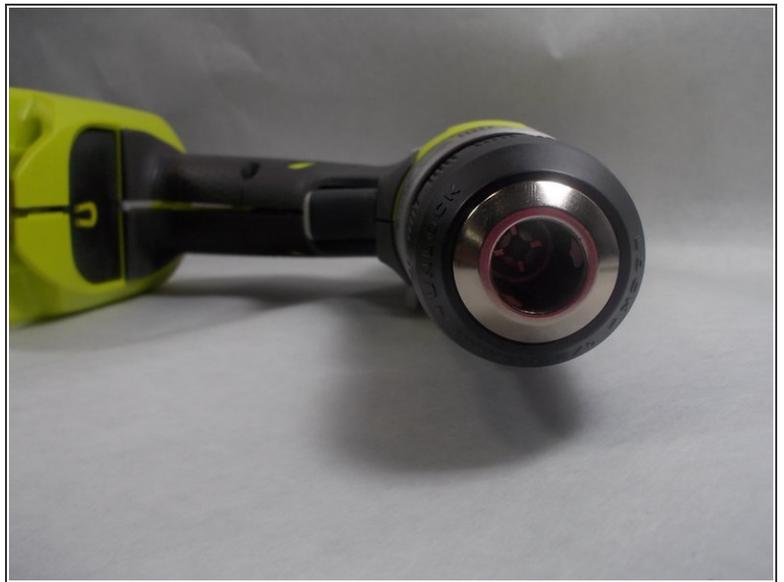
Step 4

- Remove the drill bit holder from the body of the drill.

To reassemble your device, follow these instructions in reverse order.
