# X-street Lamborghini Murcielago LP670-4 SV Steering Column Spring Replacement

This guide will cover how to replace the steering column spring.

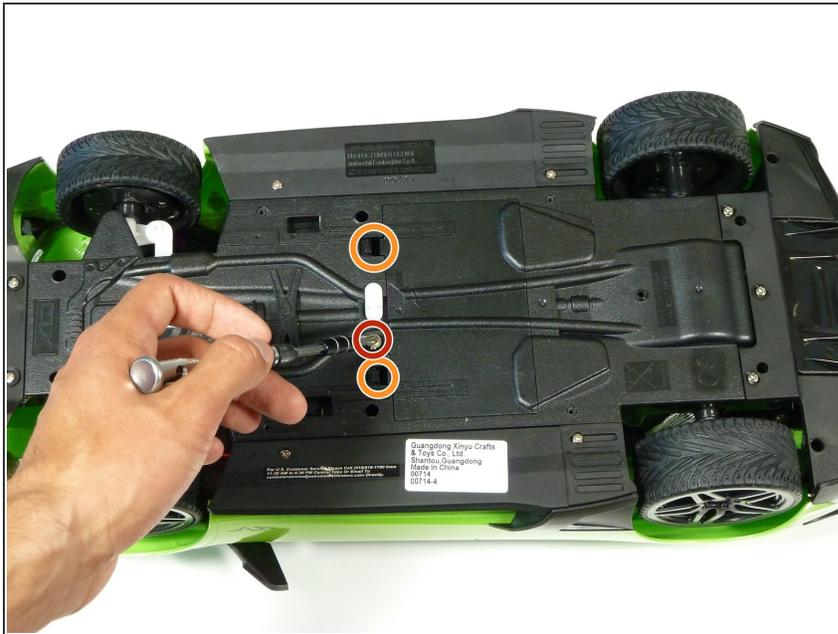
## Step 1 — Battery

- Unscrew the two 2.5mm Phillips #00 screws from the middle of the car.
- Unclip the two clips to remove the battery cover.

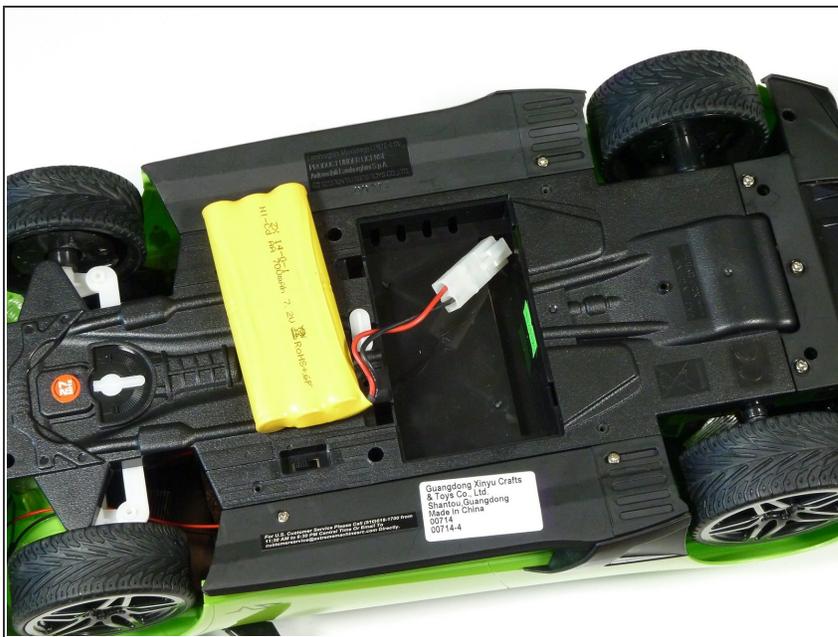
## Step 2

- Unplug the battery by pushing on the clip.

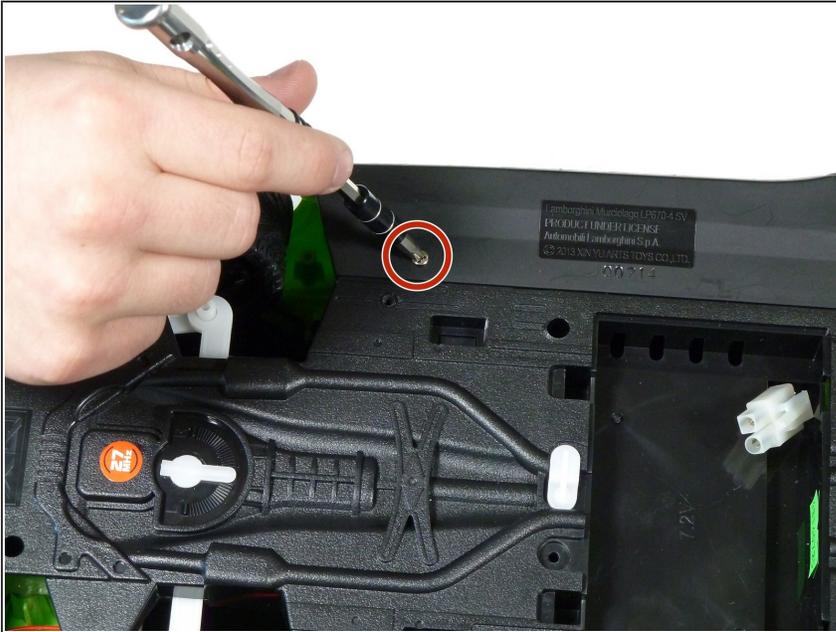
### Step 3 — Underbody

- Unscrew the two 2.5mm Phillips #00 screws from each side

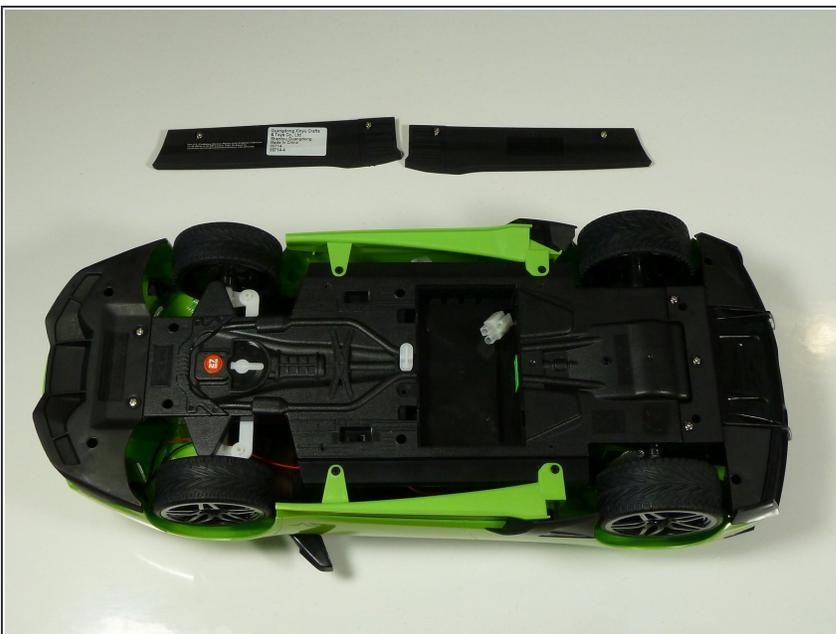
### Step 4

- Remove the side skirt covers on each side of the car.

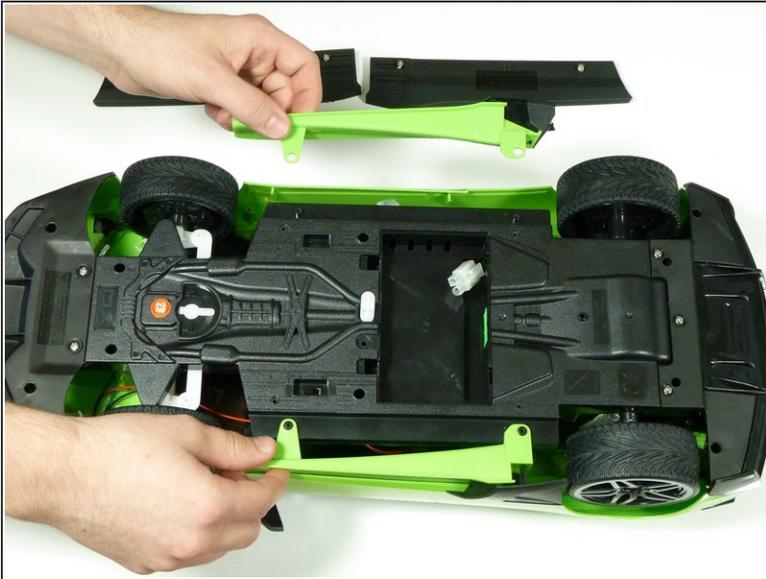
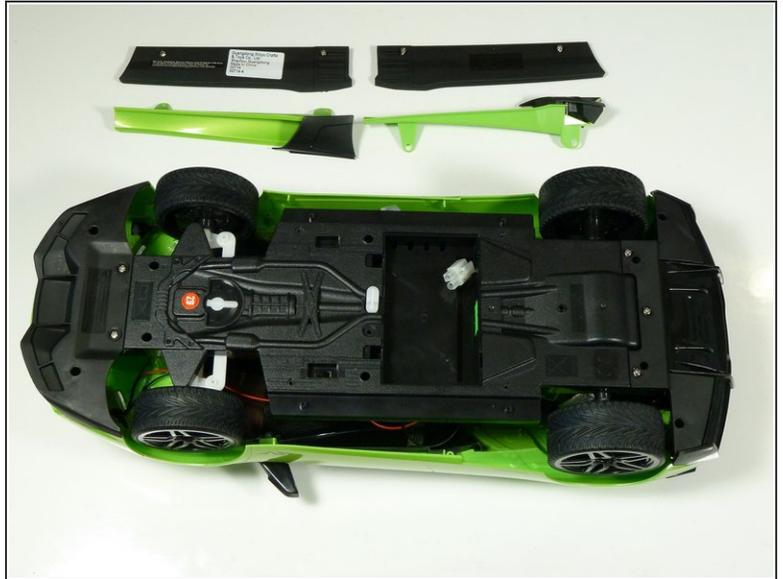
## Step 5

- Lift up and remove the two side skirts.

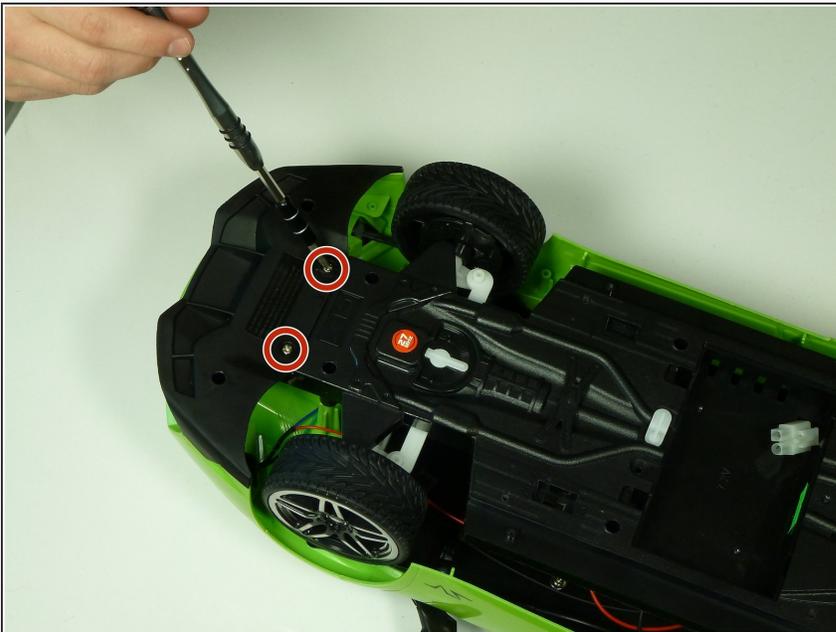
## Step 6

- Unscrew the two 2.5mm Phillips #00 screws from the front skirt of the car.

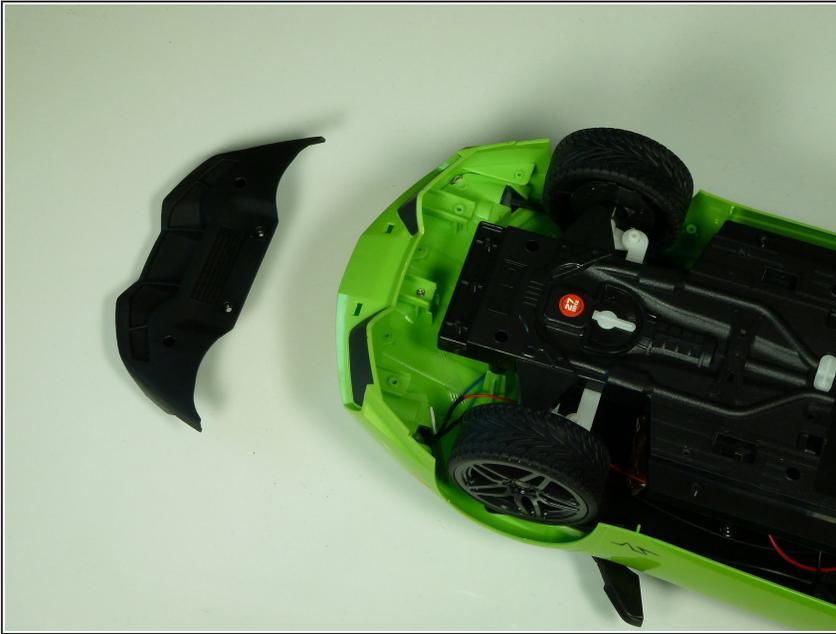
## Step 7

- Lift the front part of the underbody and pull it out from the main underbody.

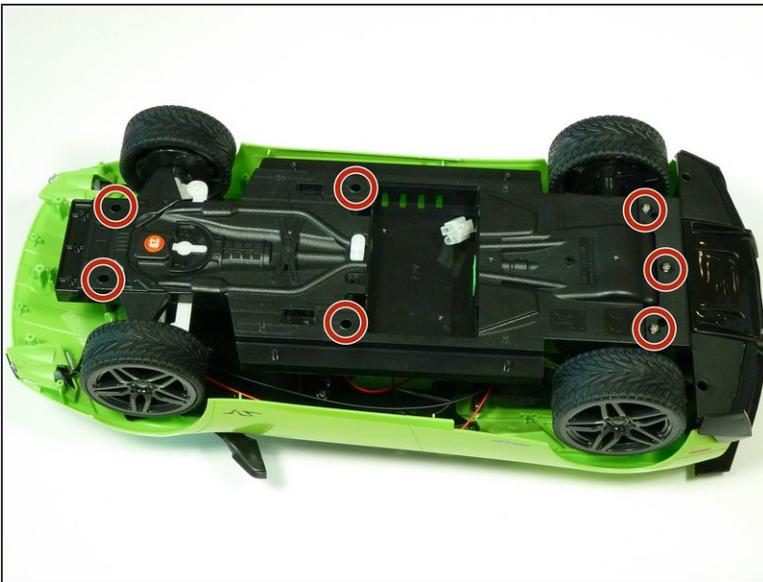
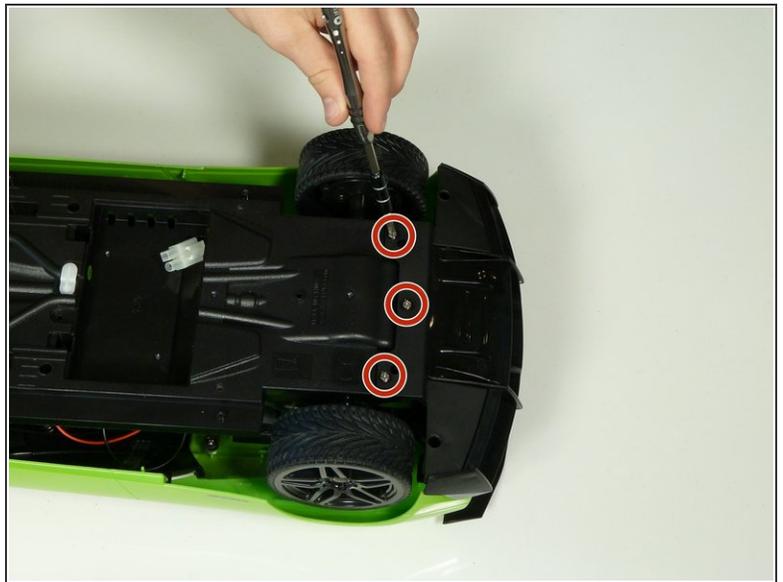
## Step 8

- Unscrew the remaining seven 9mm Phillips #00 screws from the underbody of the car.
- i** The second image shows a closer view of the rear three screws

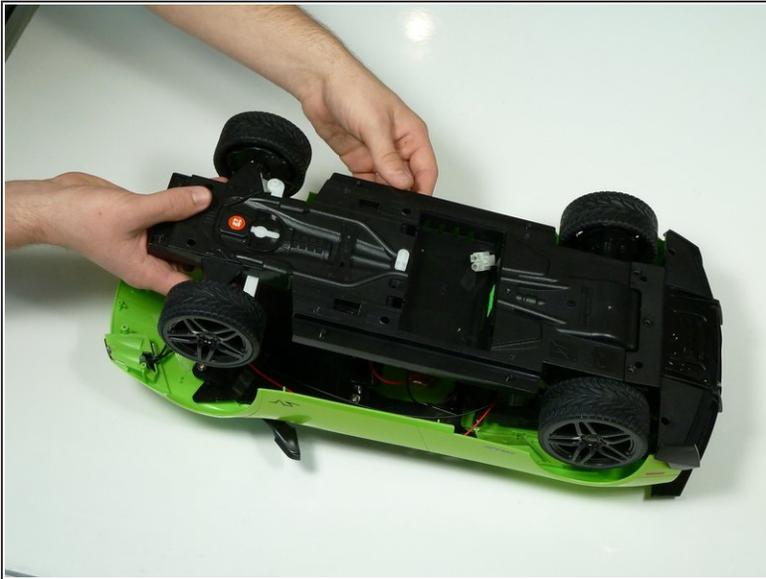
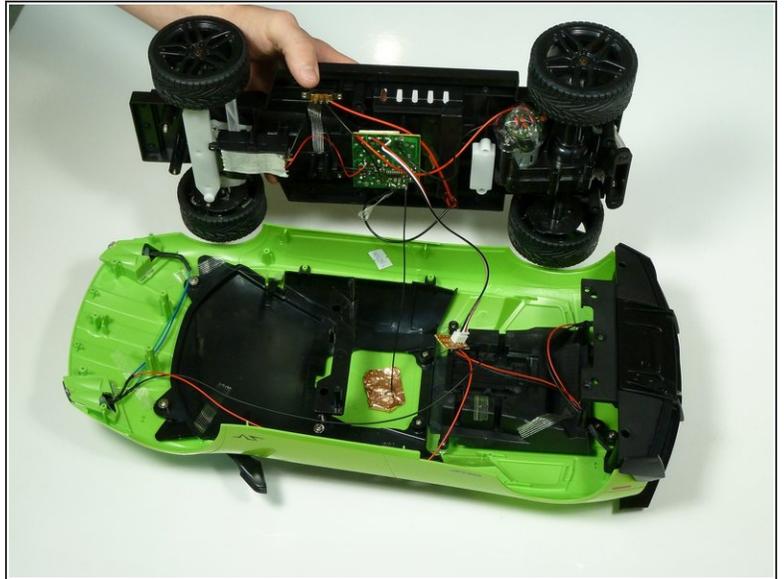
## Step 9

- Lift the main underbody from the shell of the car.
- Lift up the body to expose the wiring and hardware underneath.

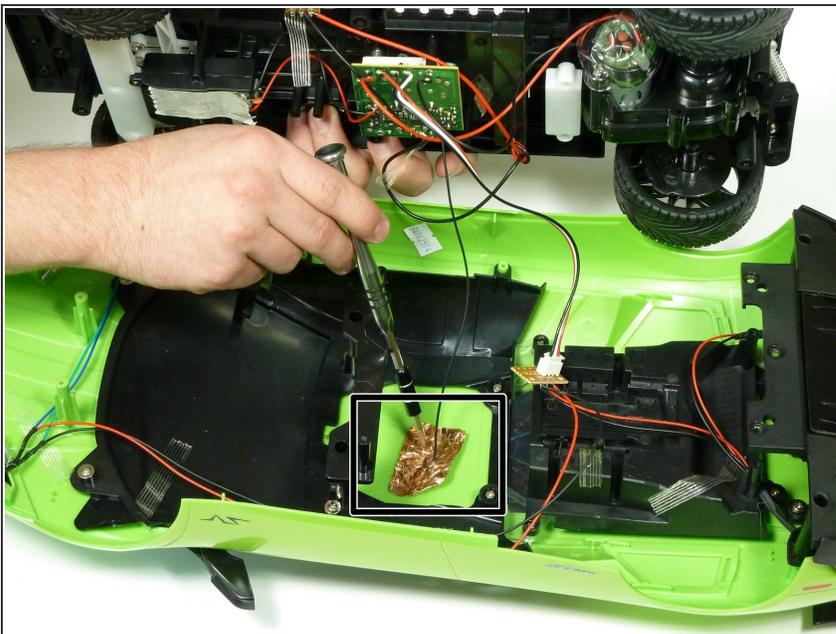
## Step 10

- Remove the reflective sticker from the top of the body.

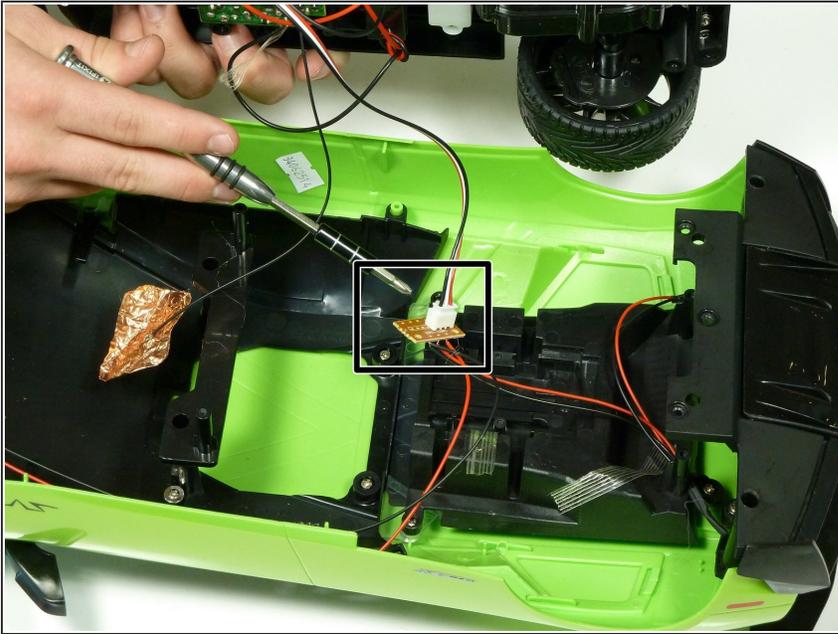
## Step 11

- Unplug the wire connector.

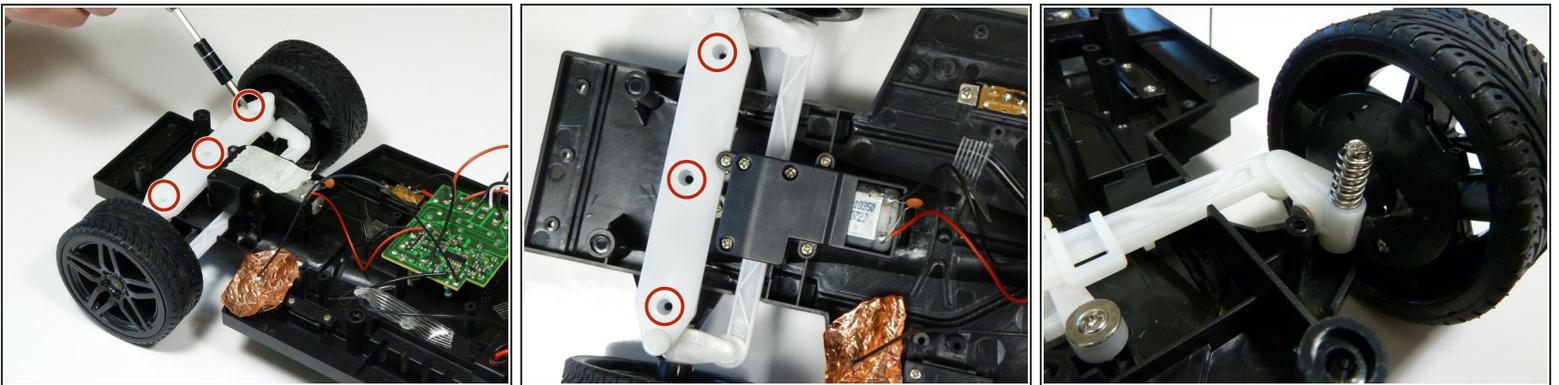
## Step 12 — Steering Column

- Unscrew the three 2.5mm Phillips #00 screws from the white steering column.

**⚠** After removing the three screws, the steering column will pop out of position because of the springs underneath. To reassemble, put the springs back together as shown in picture #3.

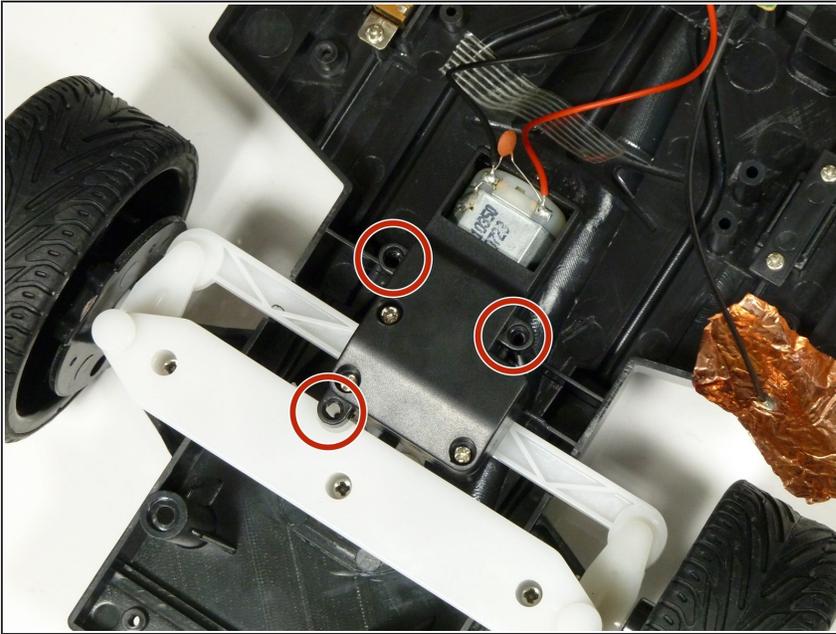
## Step 13 — Steering Column Spring

- Remove the three 1.6mm Phillips #000 screws from the black motor casing.

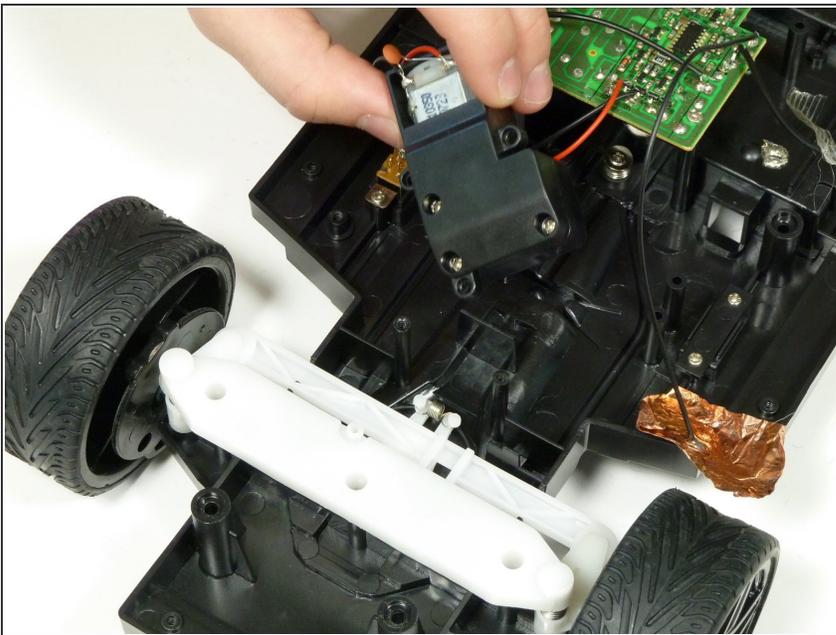
## Step 14

- Remove the front motor and its casing from the chassis of the car.

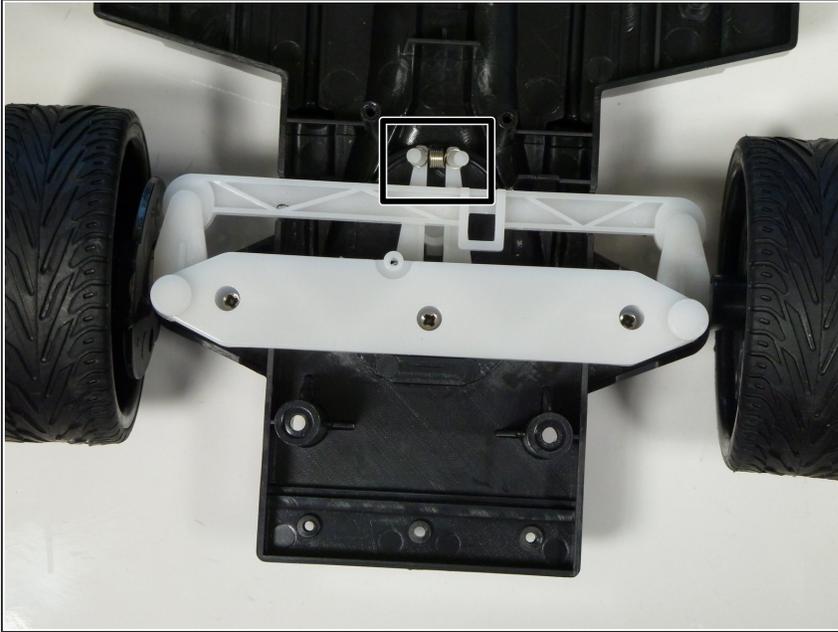
## Step 15

- Carefully remove the steering column spring.

To reassemble your device, follow these instructions in reverse order.
